Melbourne Pre Purchase Property Inspections (MPPPI)

BUILDING INSPECTION REPORT

Building Type: Residential House
Description: Single Storey, 20-25 Squares of living, Garage
Estimated Age: 15-20 years old
Foundation Type: Concrete slab
Walls External: Brick veneer, Bagged and painted brickwork
Roof: Concrete roof tiles
Furniture: No
Weather Condition: Fine

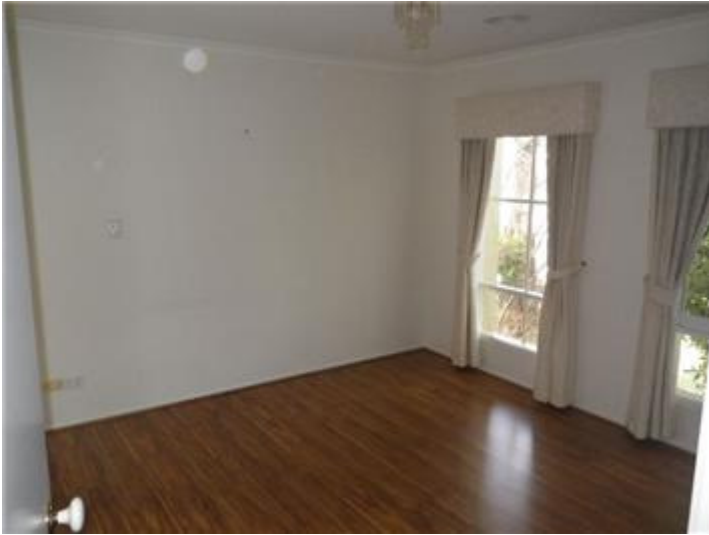
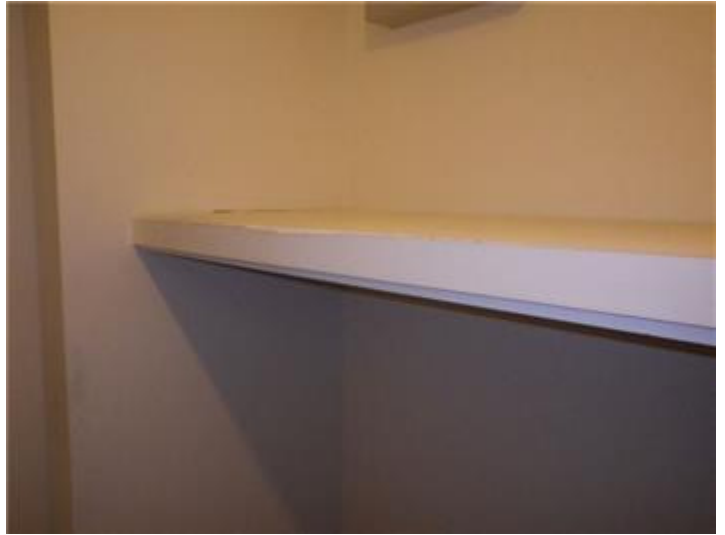
Master Bedroom

All appears to be in good condition with little maintenance required
Shelving in robe require extra support as they have bowed, this can be achieved with brackets or a stronger front rail

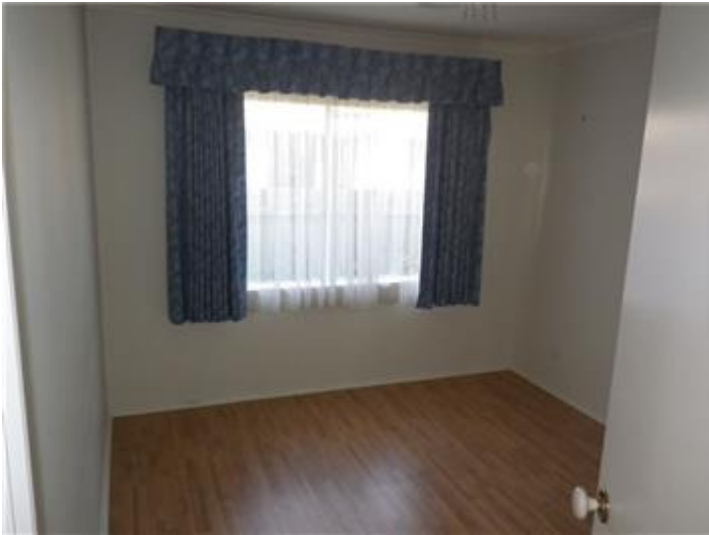
Bedroom 2

All appears to be in good condition with little maintenance required
Robe doors require adjustment as they are binding, most likely due to movement and should be monitored

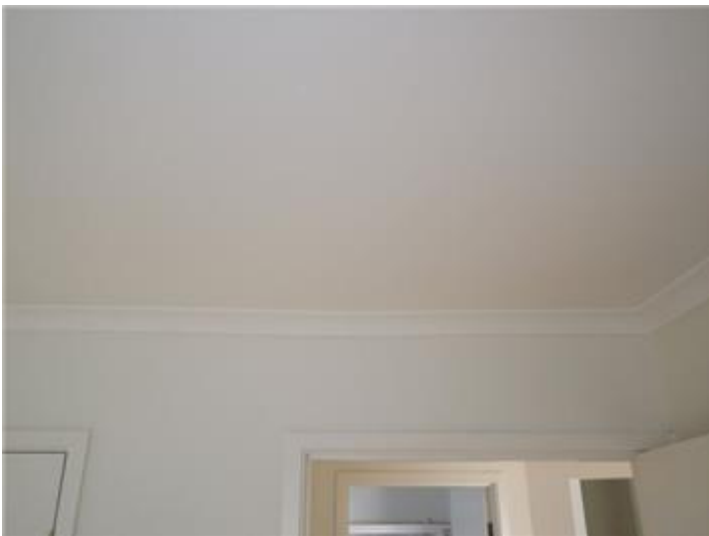
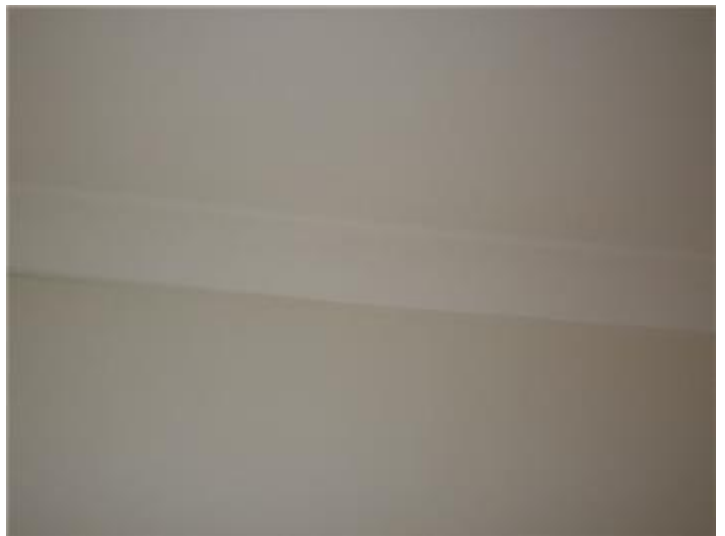
Ceilings

Dip noted in cornice in areas and is due to the timber roof truss flexing causing movement in plaster and should be monitored. This is common and generally around the girder trusses which take a lot more roof load than other trusses. If dipping continues then should be assessed by an engineer.

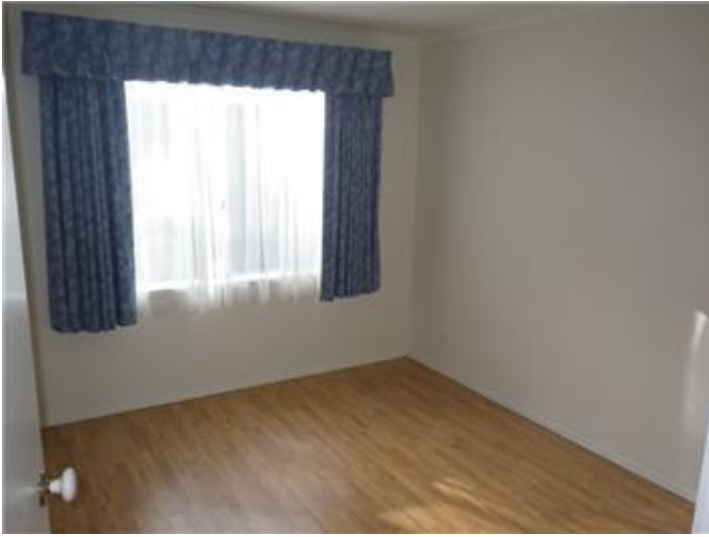
All appears to be in fair to good condition with some maintenance required
No smoke detector fitted outside bedroom, this is a current council requirement and should be rectified for your own safety

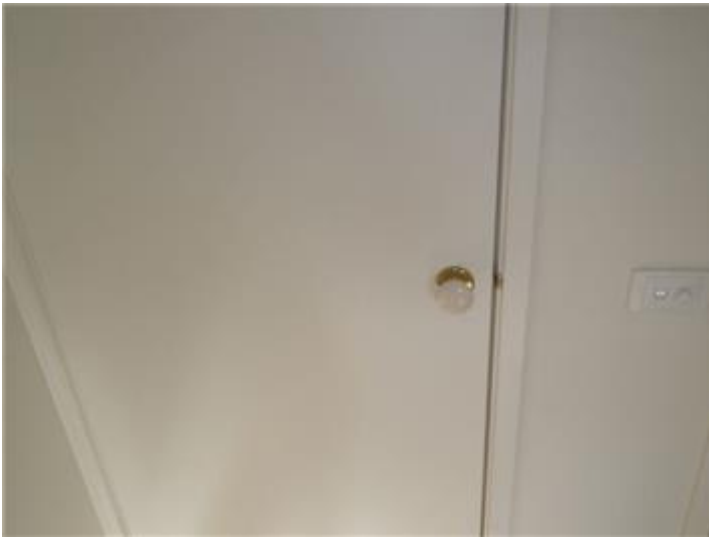
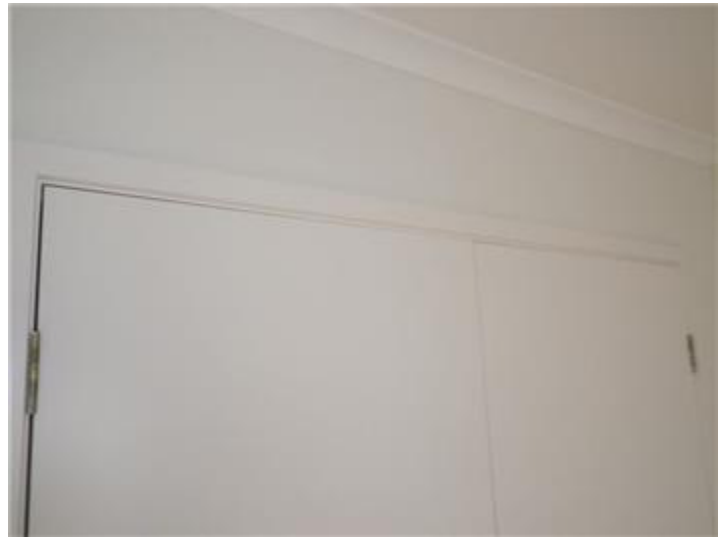
Doors require adjustment

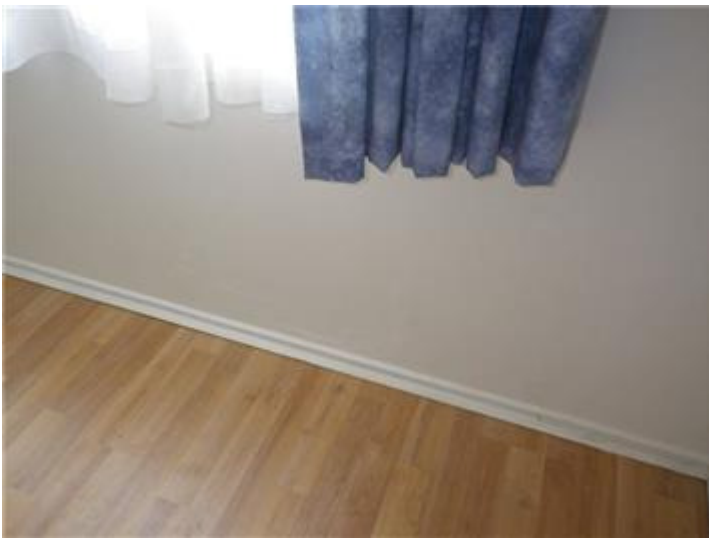
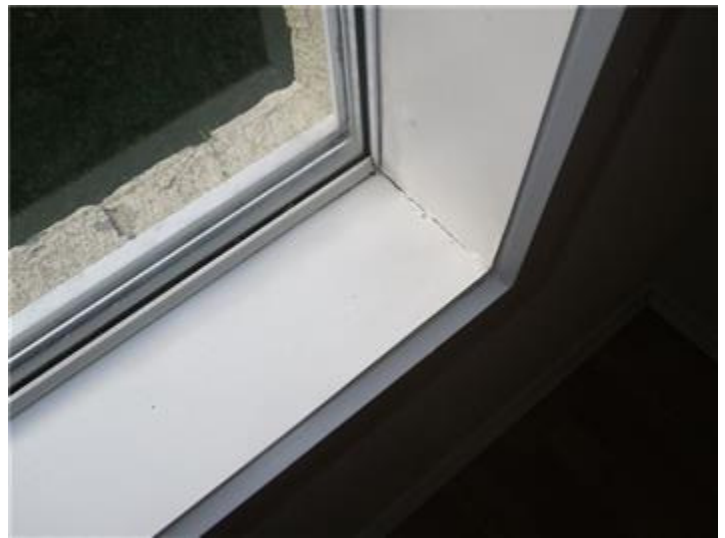
Walls have been patched in areas, repairs have been made due to movement
Window sill has been patched so could be from moisture

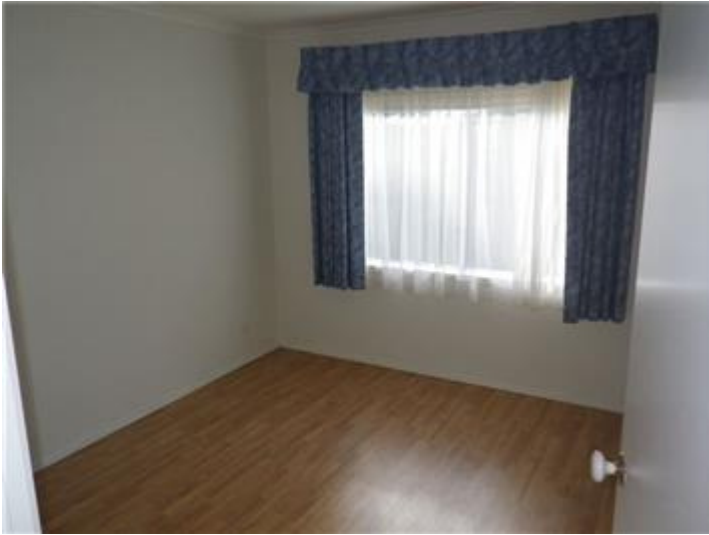
All appears to be in fair to good condition with some maintenance required
No smoke detector fitted outside bedroom, this is a current council requirement and should be rectified for your own safety

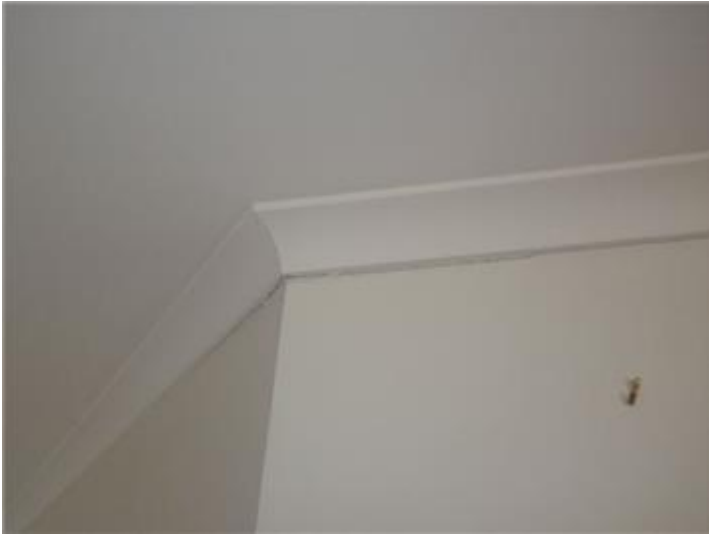
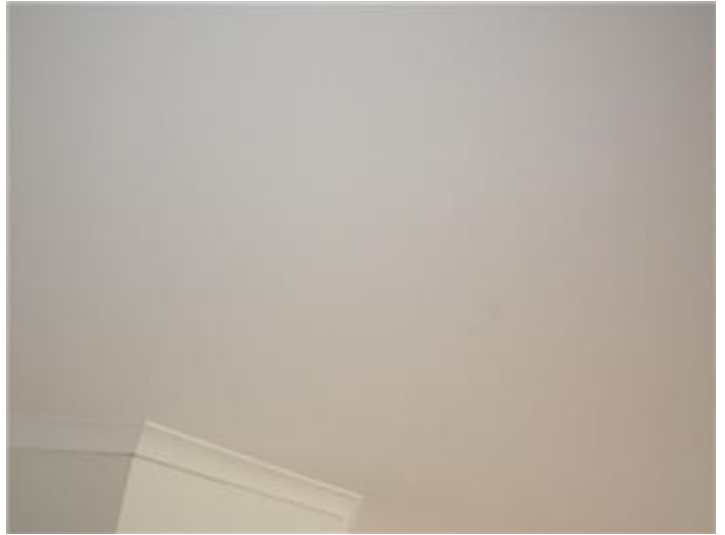
Ceilings Cornice is coming away from walls in areas and requires some refixing with cornice adhesive
Minor movement noted between plaster sheets at joint, minor repairs required and is unknown if they will return

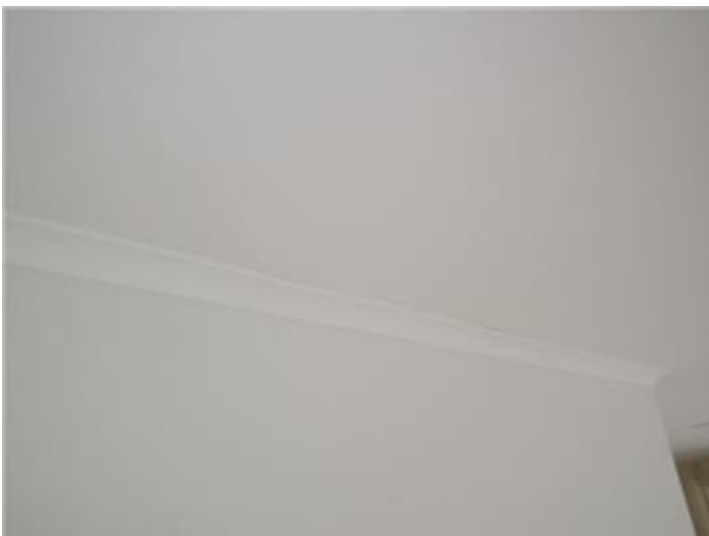
Ceilings Dip noted in cornice in areas and is due to the timber roof truss flexing causing movement in plaster and should be monitored. This is common and generally around the girder trusses which take a lot more roof load than other trusses. If dipping continues then should be assessed by an engineer.

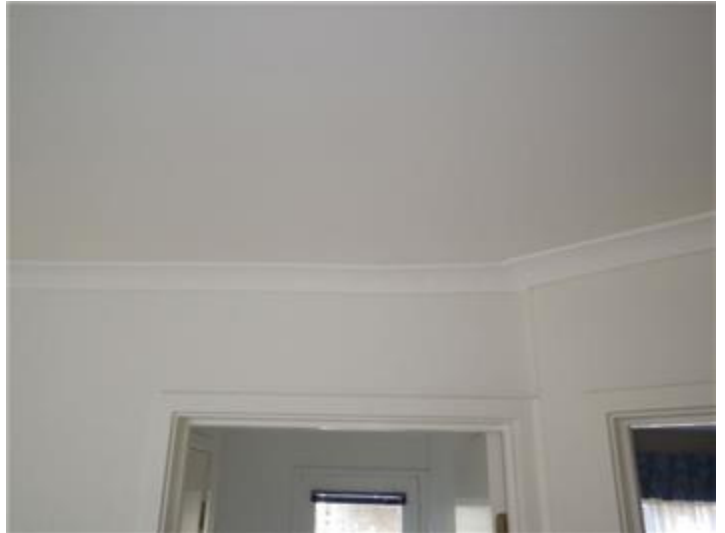
Ceilings

Minor movement noted between plaster sheets at join, minor repairs required and is unknown if they will return
Dip noted in cornice in areas and is due to the timber roof truss flexing causing movement in plaster and should be monitored. This is common and generally around the girder trusses which take a lot more roof load than other trusses. If dipping continues then should be assessed by an engineer.

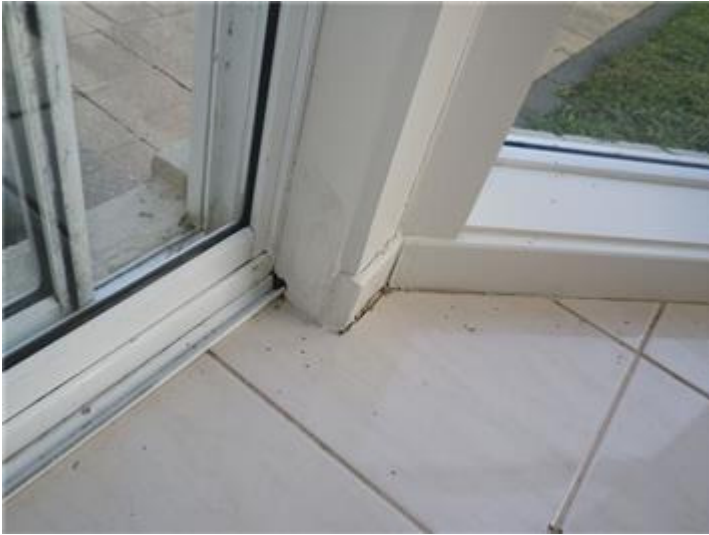
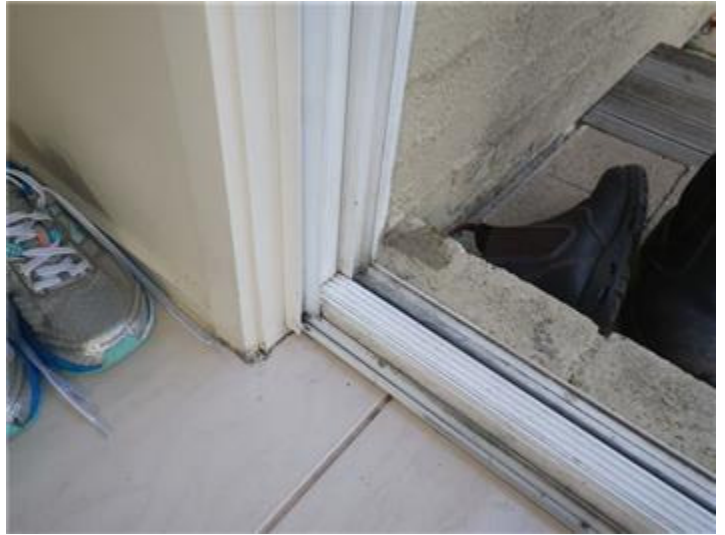
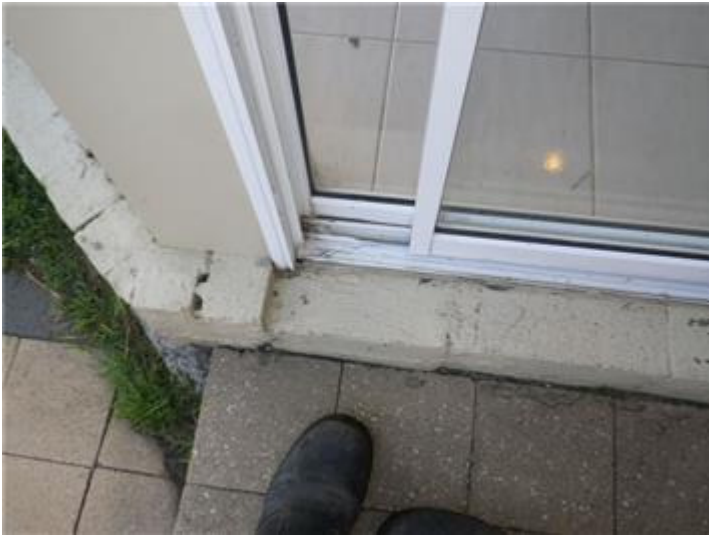
Doors

Some high moisture readings and damage to bottom of door jamb, water entering around brick sill
Requires sealing, brick sill may be to flat so water not running off

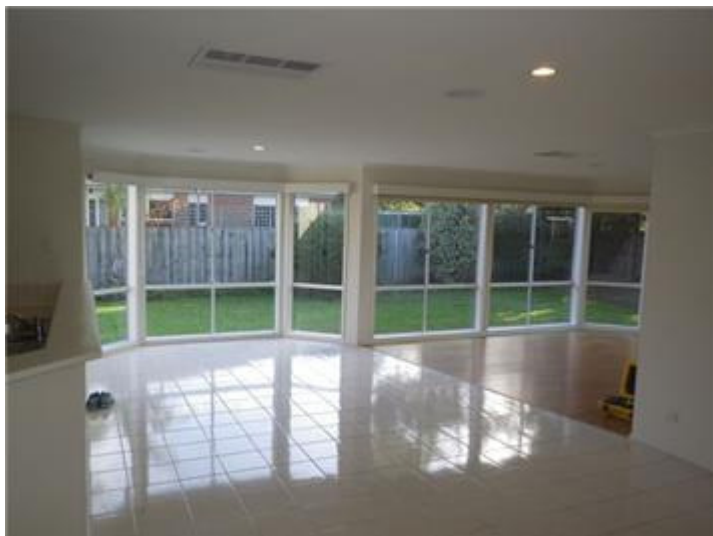
Hair line cracks noted to floor tiles in areas, could be due to movement as no expansion joints have been installed
Loose tiles noted in areas, could be due to movement or poor preparation when laid

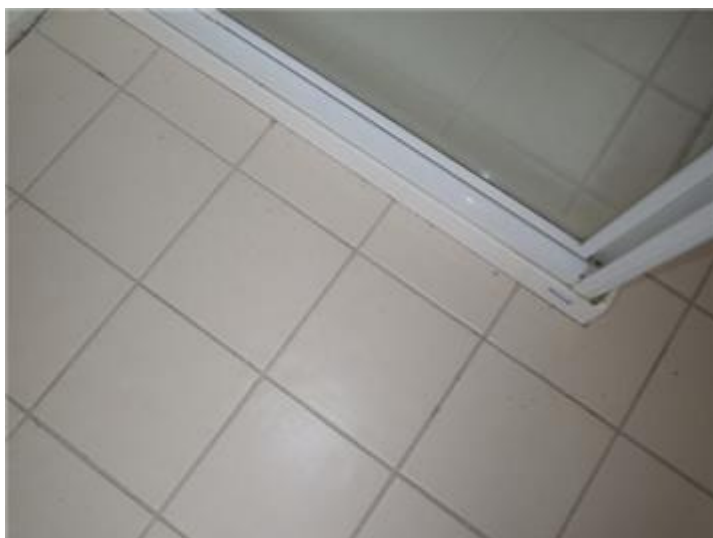
Floors Hair line cracks noted to floor tiles in areas, could be due to movement as no expansion joints have been installed

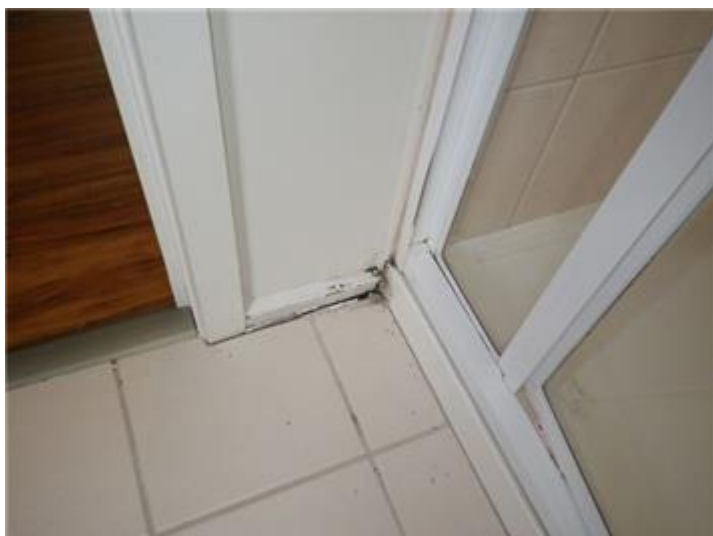
Wall tiles High moisture recorded behind bottom row of tiles of shower, this is a very common problem and can cause tiles to dislodge from wall over time and depends on what tile adhesive was used and how well applied
Moisture has affected timbers next to shower and will continue if tiles are not sealed or leaks fixed
Tiles and grout should be well dried and then sealed in shower, this is to manufactures recommendations. The sealer is clear and can not be seen once dry

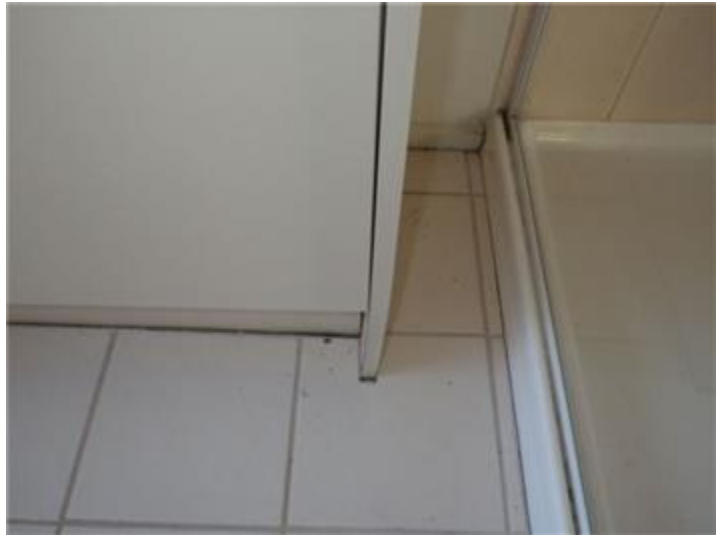
Vanity Unit

Water damage noted to base of vanity unit and requires repairs
Should be replaced

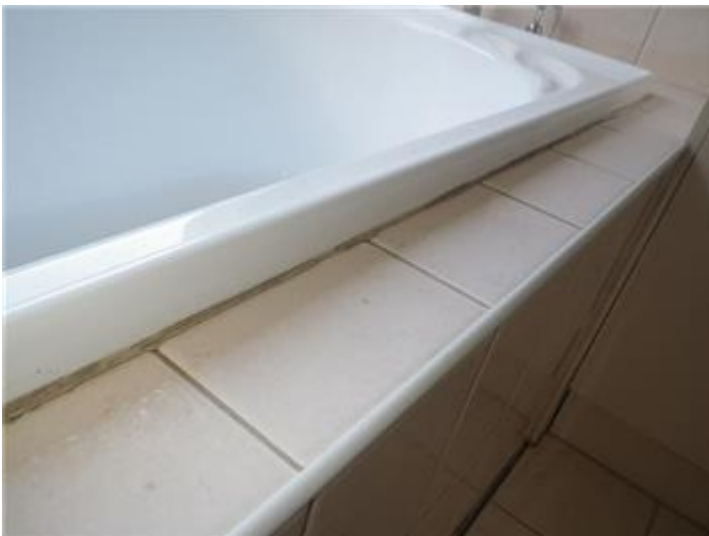
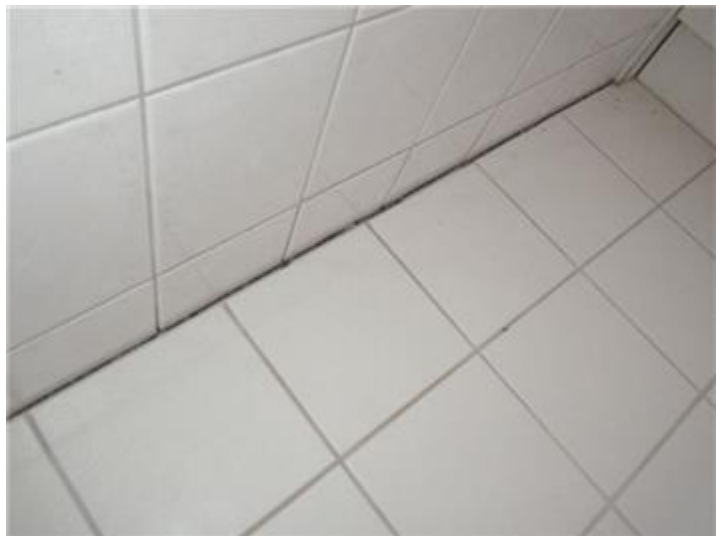
Wall tiles

Moisture has affected plaster next to shower and will continue if tiles are not sealed or leaks fixed
Silicon required between floor and wall tiles
Silicon required between bath and tiles

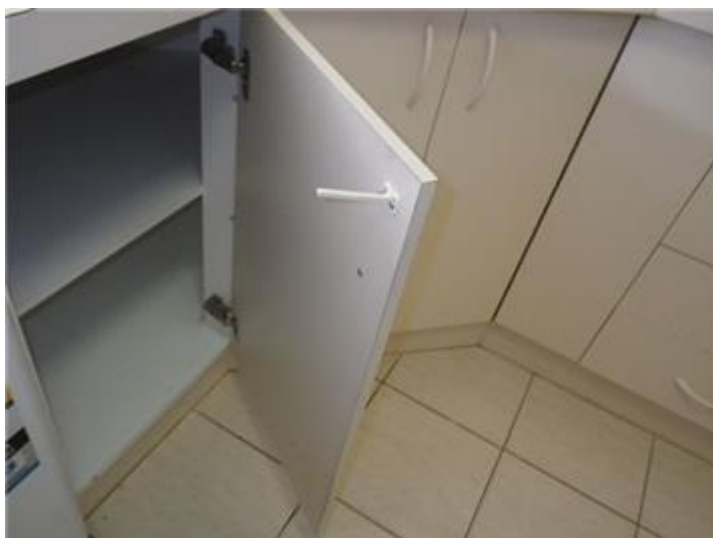
Cupboards

Doors require adjustment so they function properly

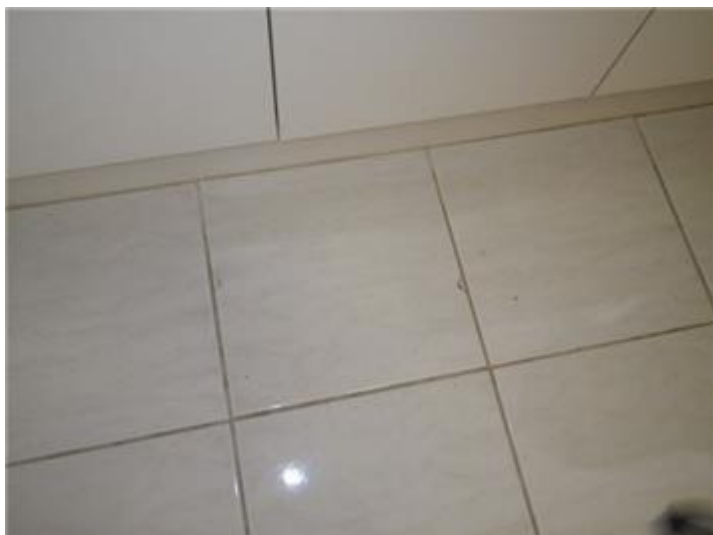
Floors

Chipped tiles noted in areas

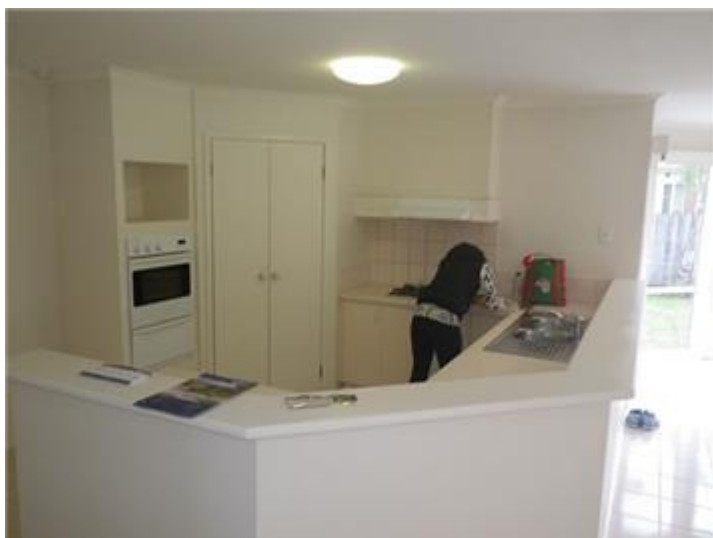
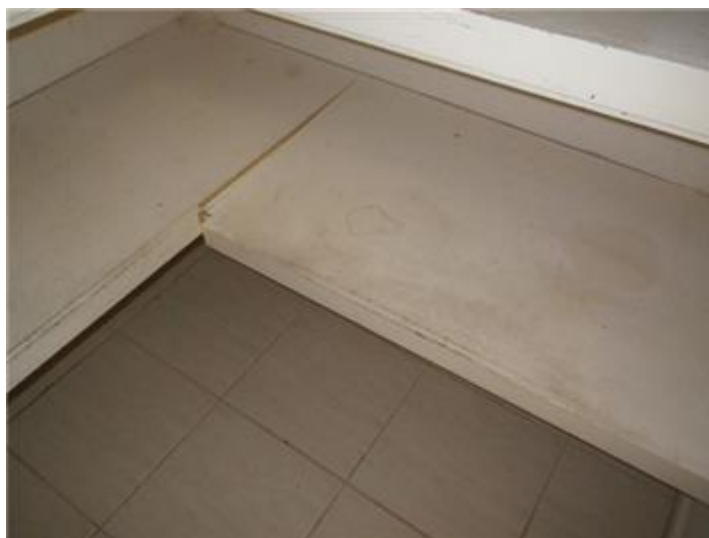
All appears to be in fair to good condition with some maintenance required
Shelving in pantry requires extra support as they have bowed, this can be achieved with brackets or a stronger front rail

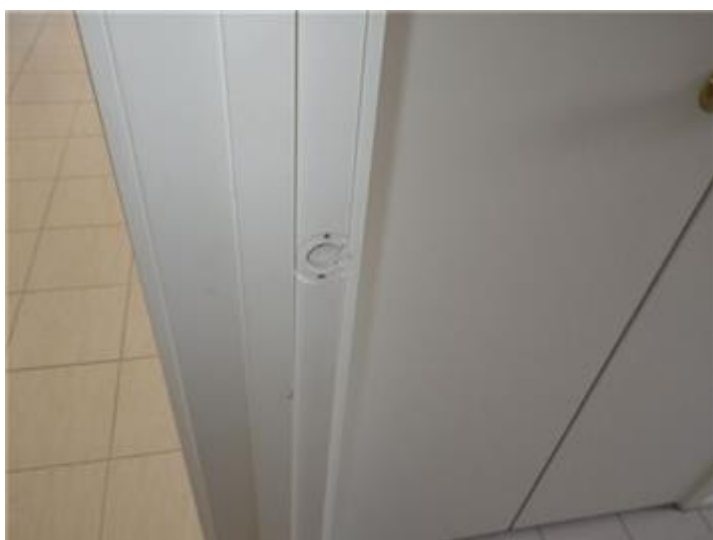
Doors

Striker plate missing on door jamb

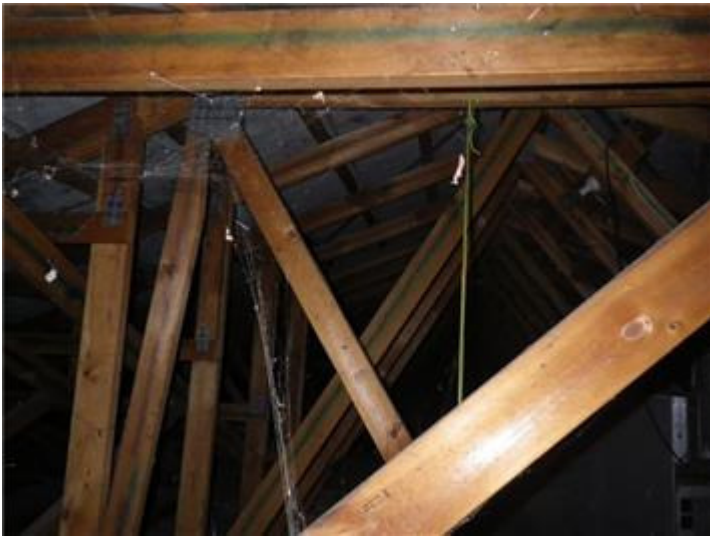
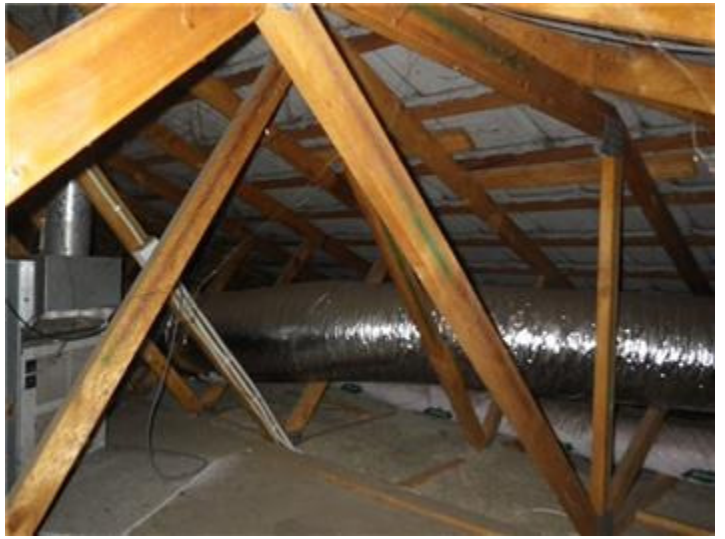
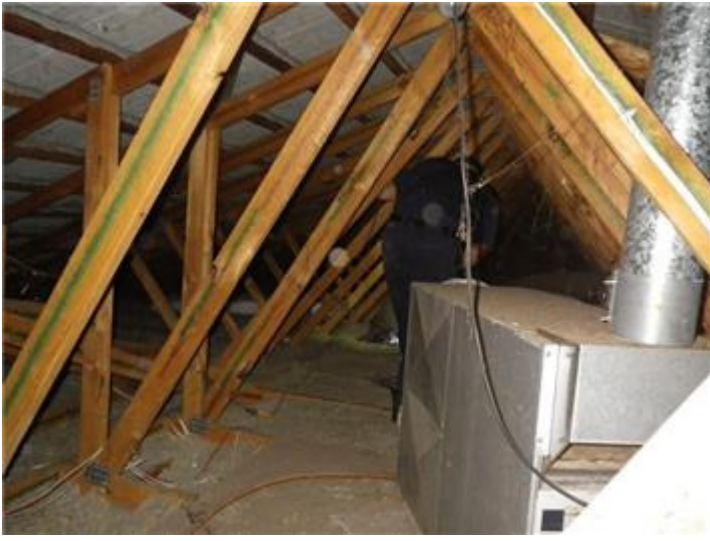
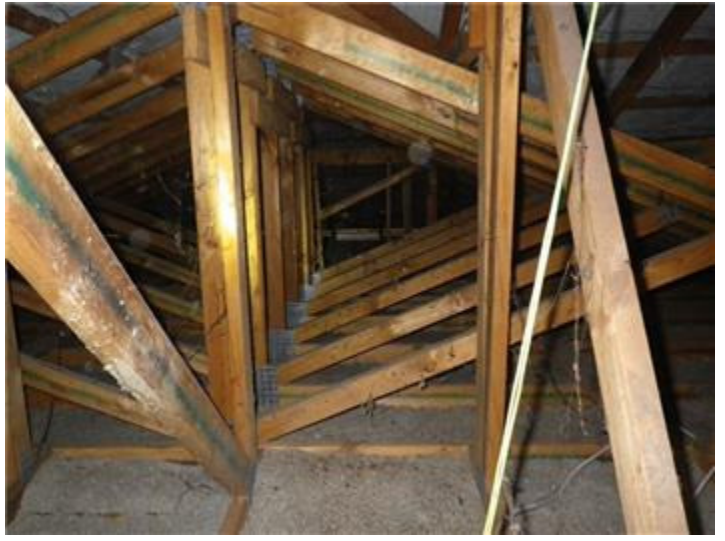
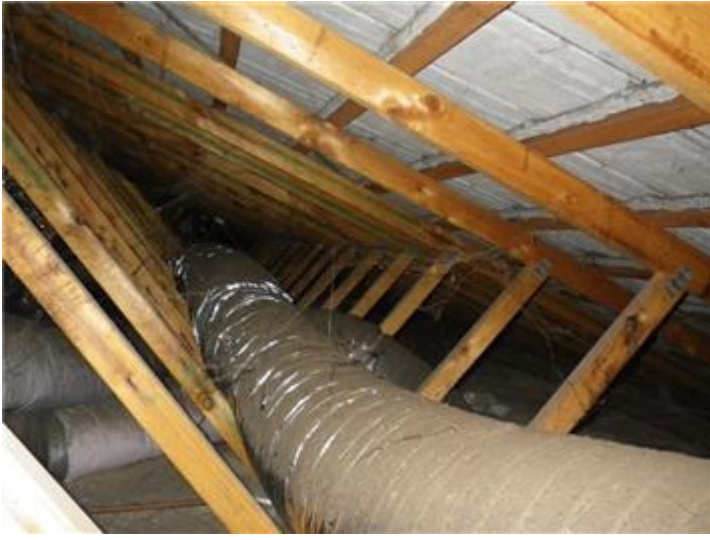
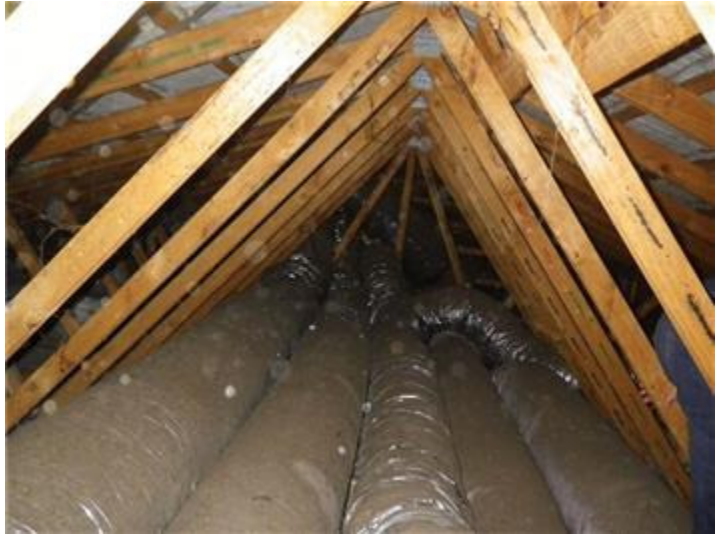
Some settlement was noted to girder trusses which have additional weight, this is to be expected to some degree and should be monitored. A timber block can be put between wall top plate and bottom cord of truss in roof space if settlement continues but should only be where webbing of truss is located and direct propping in internal walls.

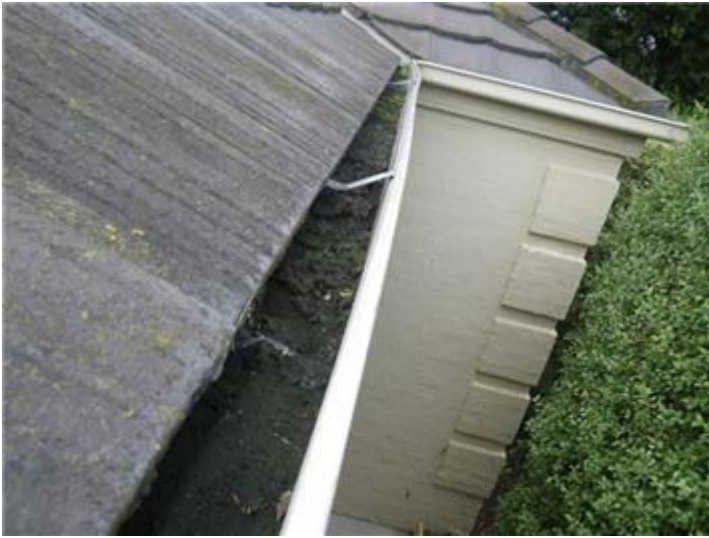
**Gutters**

Gutters require cleaning, this will prevent rust and will last longer

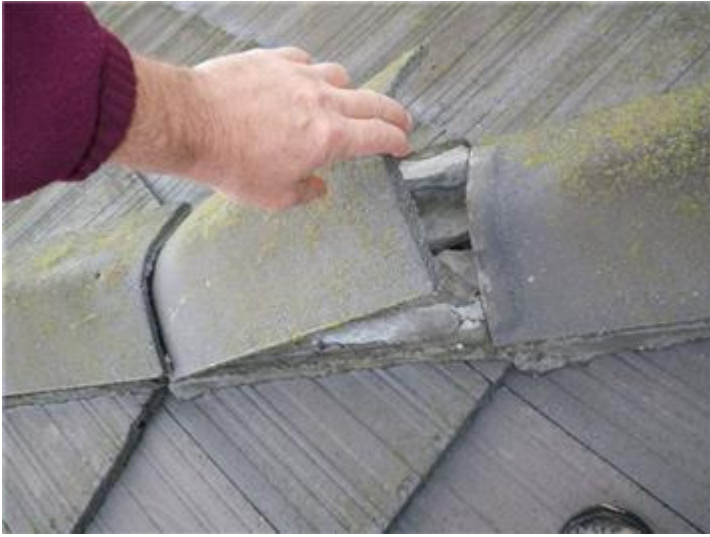
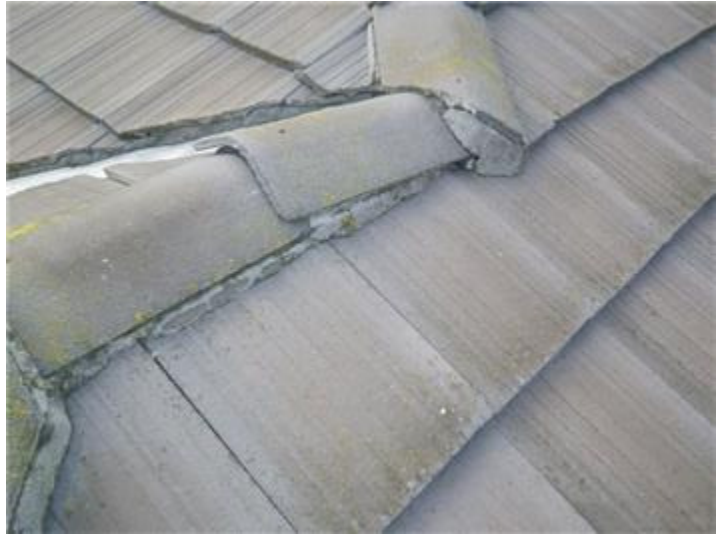
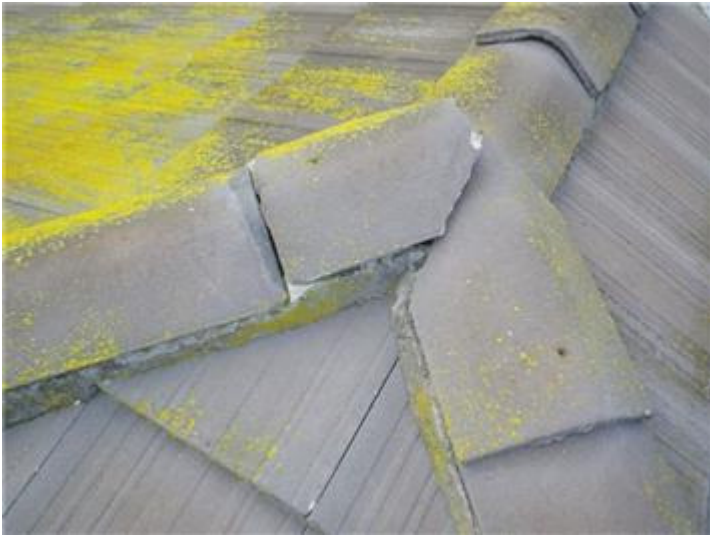
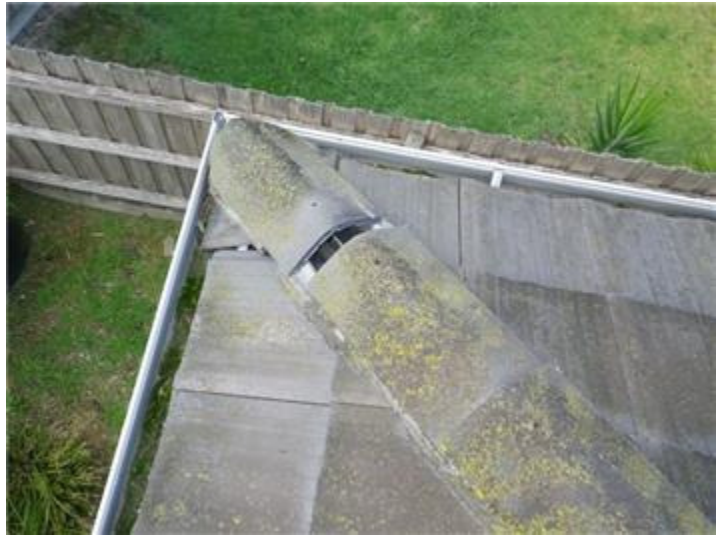
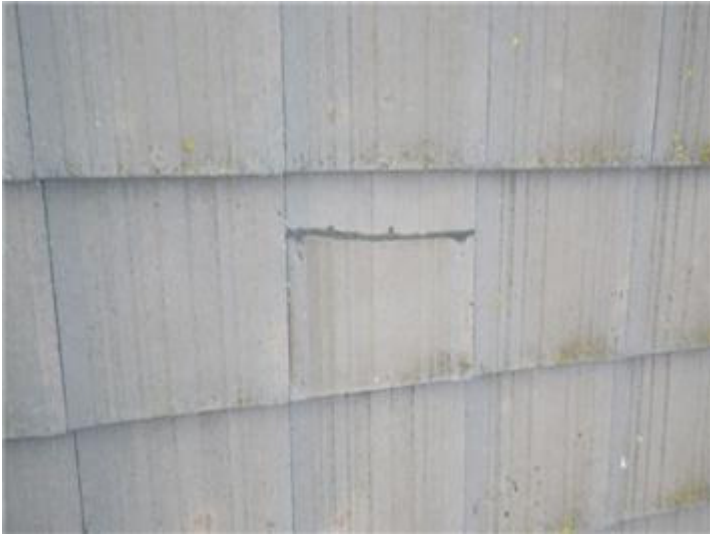
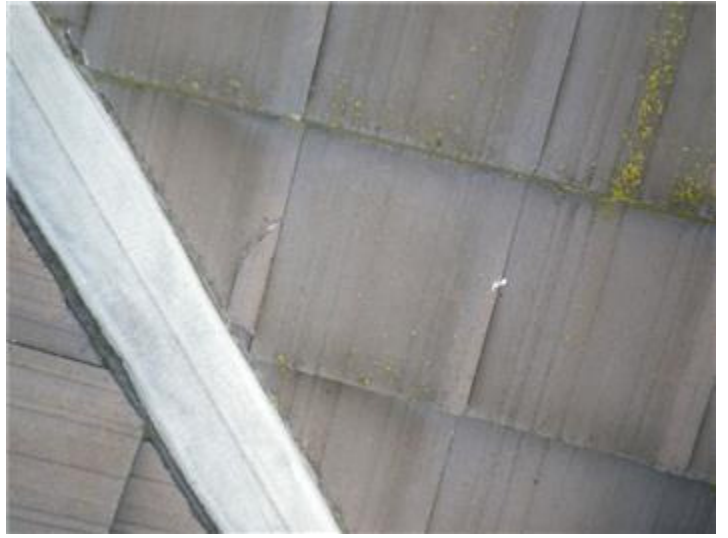
Roof Coverings

Roof tiles may require re bedded in areas and re pointed to ensure that no leaks occur, roof tiler to evaluate
Some cracked tiles noted in areas, these should be replaced as leaks are possible
The possibility of the roof leaking soon in an average rainfall is low once cracked tiles are replaced and re pointed
Roof tiler required to evaluate further

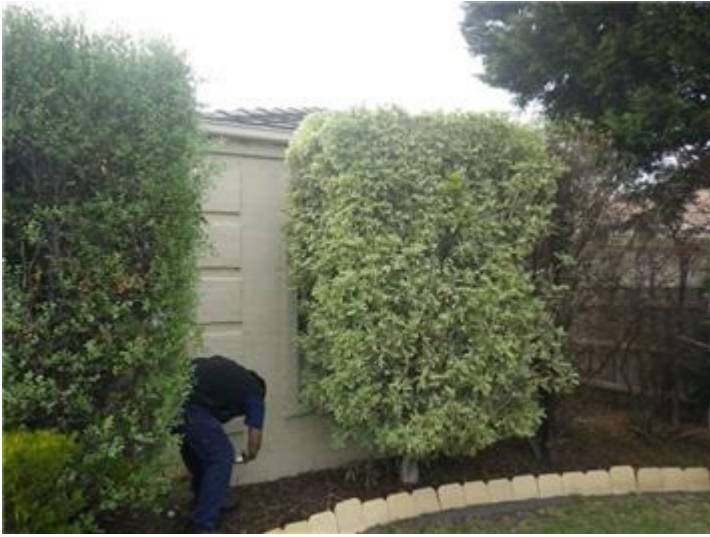
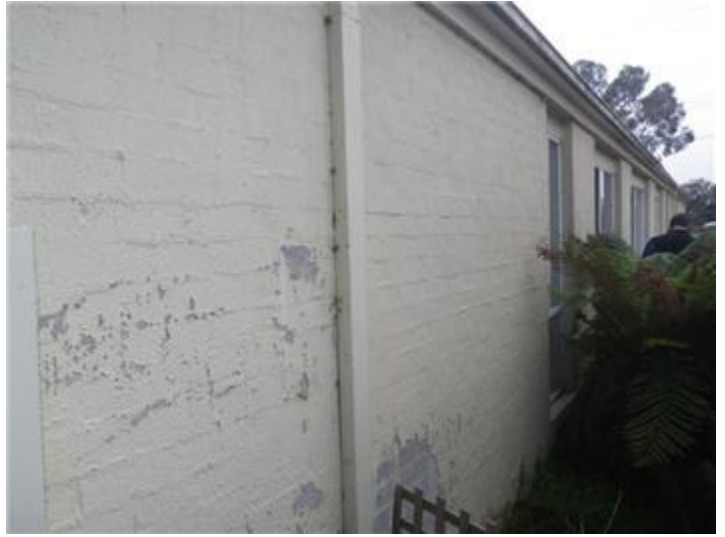
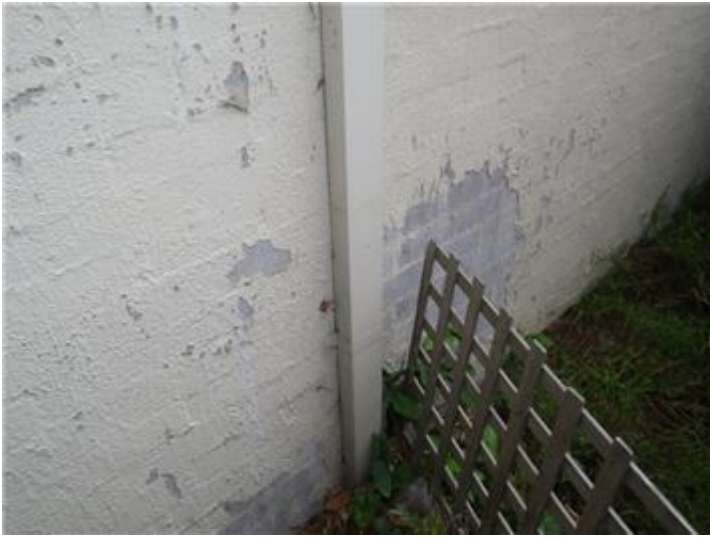
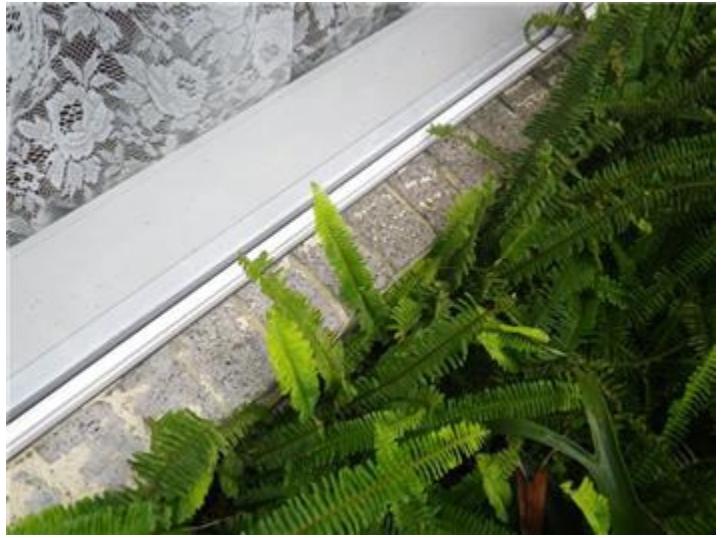
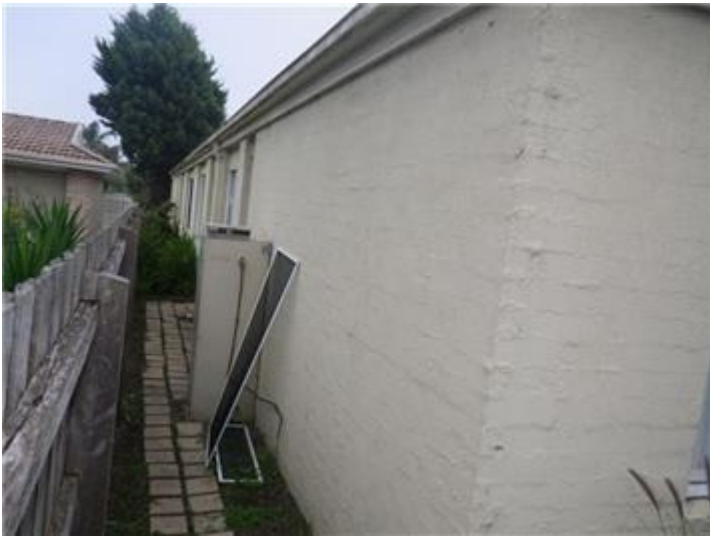
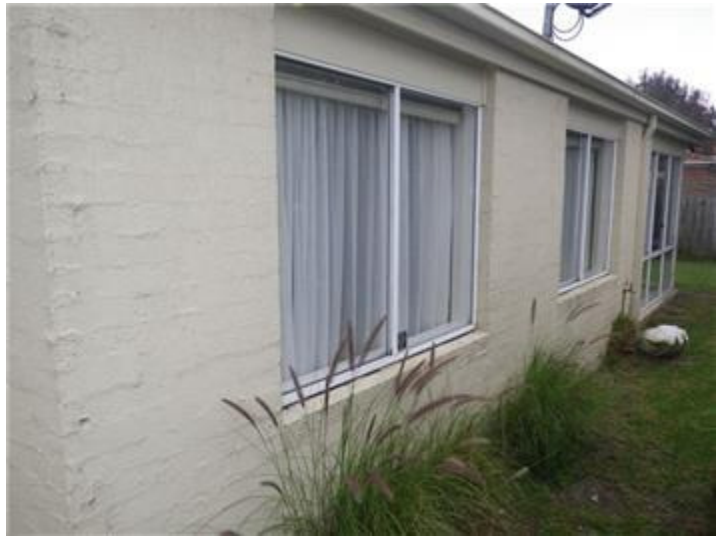
Walls

Minor movement noted in areas around dwelling and should be monitored
If you are concerned about movement increasing in size or further movement to the dwelling then a geotechnical report (soil report) will have to be commissioned. It is unrealistic for us to comment on conditions that can not be determined from a visual inspection, in other words what is happening under the dwellings foundations.
There were areas where paint was peeling off, maybe due to poor preparation
Painting required

Where drainage or gutter/downpipe problems exist around a dwelling, these can have an affect on the dwellings foundations due to changing soil conditions
Where trees are to close to the dwelling this could affect the performance of the footing as the moisture levels change in the ground. A Geotechnical Inspection can determine the foundation material and advise on the best course of action with regards to trees. large trees have been known to affect house foundations up to 1.5 times their height.

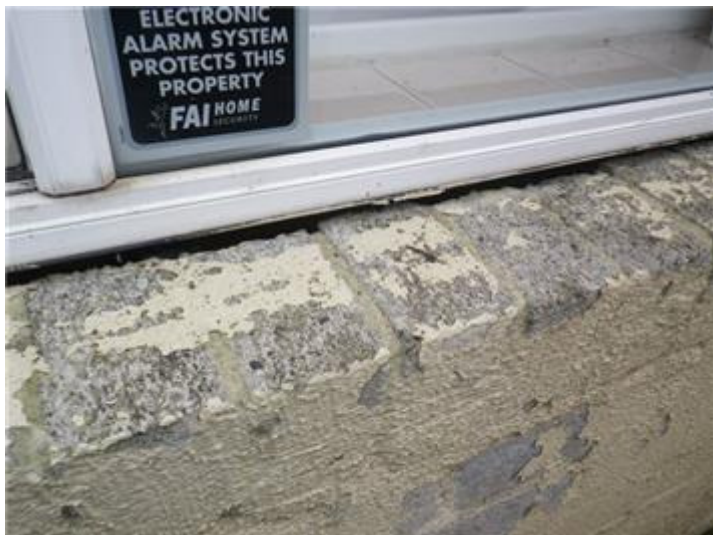
Comments Some window rubber seals are missing or deteriorated, require attention

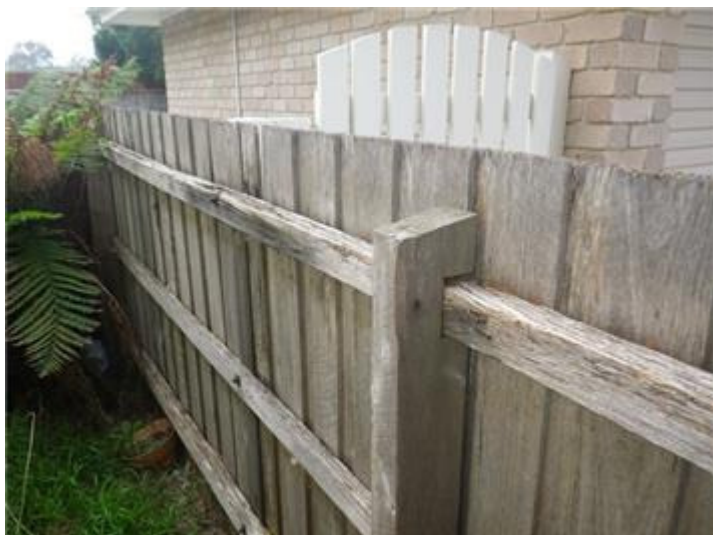
Fences Rot evident to mostly timber rails
Will require replacement in around 2 years

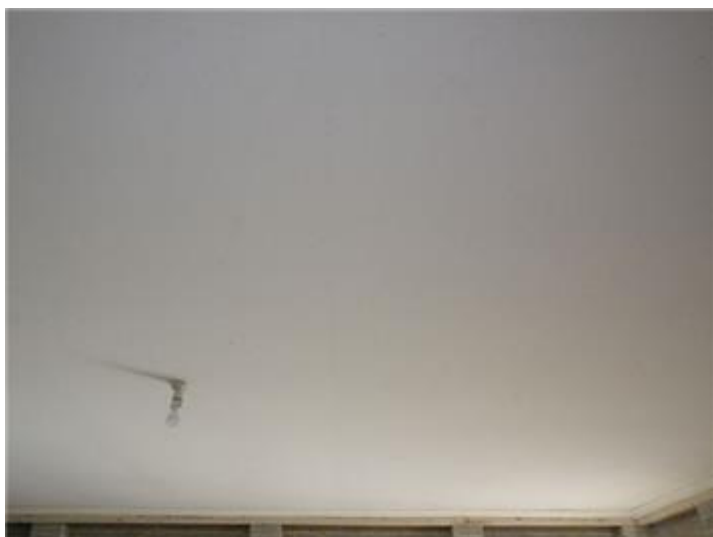
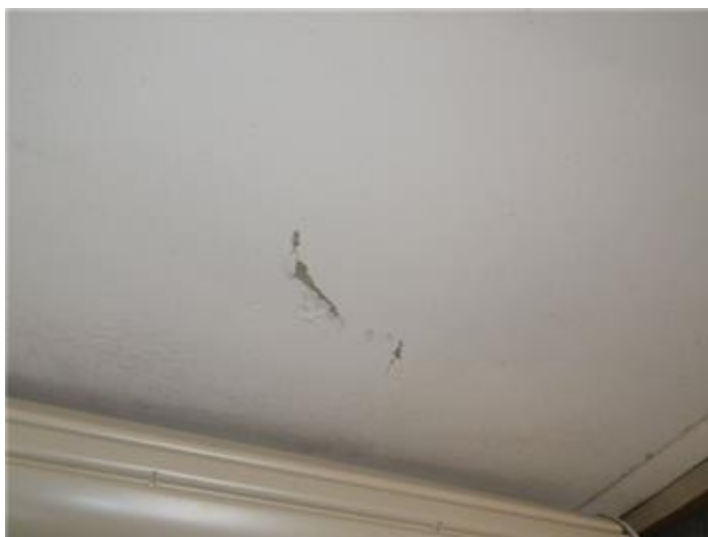
Ceilings Minor movement noted between plaster sheets at join, minor repairs required and is unknown if they will return
Water mark noted and moisture recorded, pointing required to roof tiles

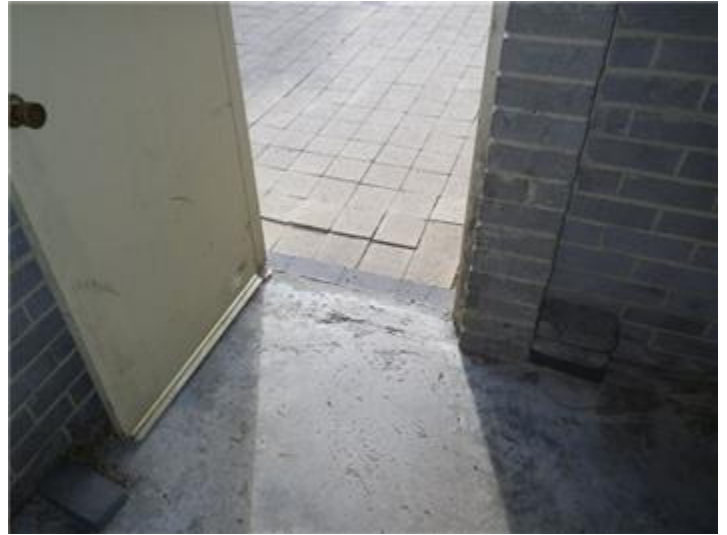
Doors Door is damaged
Surface water may run into garage
