Melbourne Pre Purchase Property Inspections (MPPPI)

BUILDING INSPECTION REPORT

Building Type: Residential House
Description: Single Storey, 20-25 Squares of living, Garage
Estimated Age: 15-20 years old
Foundation Type: Concrete slab
Walls External: Brick veneer, Bagged and painted brickwork
Roof: Concrete roof tiles
Furniture: No
Weather Condition: Fine

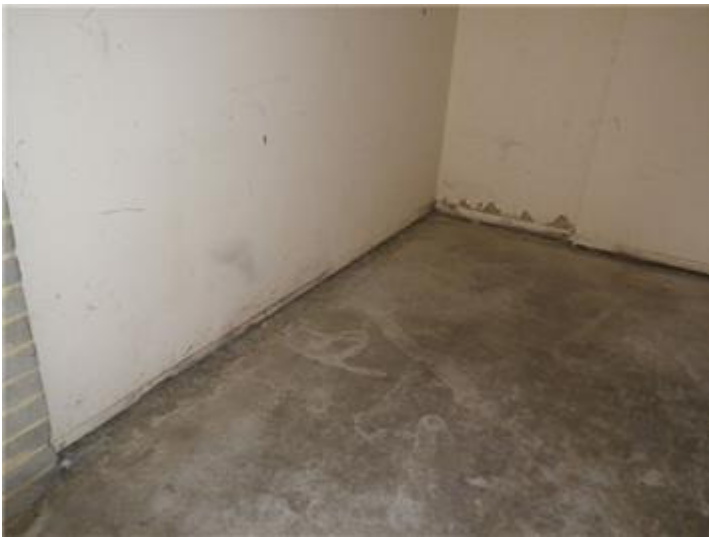
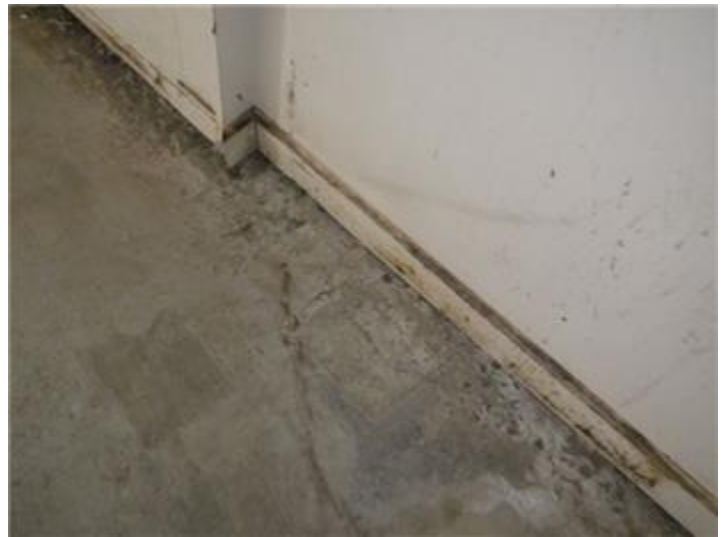
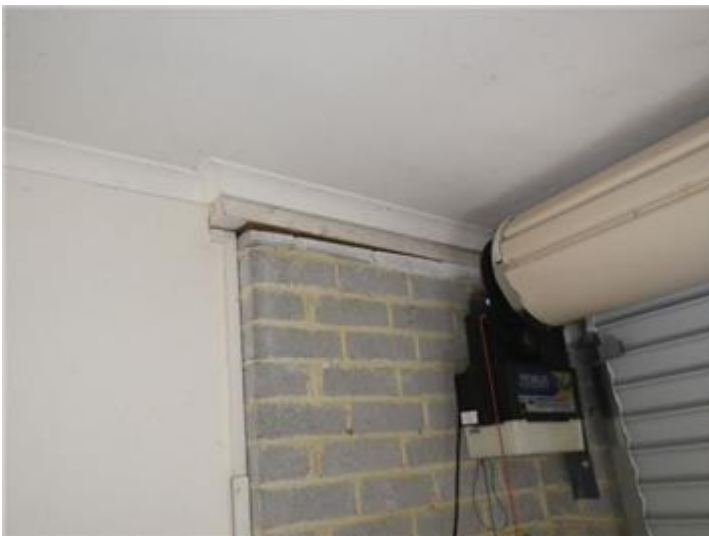
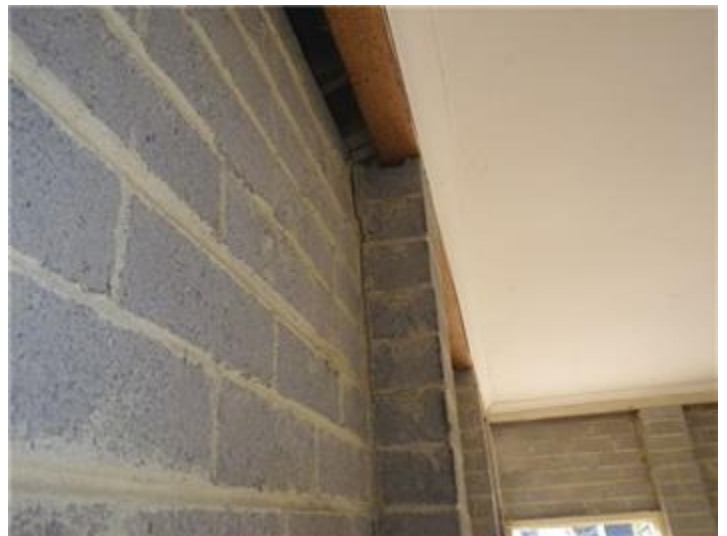
Walls

Skirting boards have been removed, others have water damage

It appears that some settlement has occurred to brick wall next to roller door, should be monitored
Can not see any cracking just a gap between bricks and timber plate

Minor movement noted to brick piers

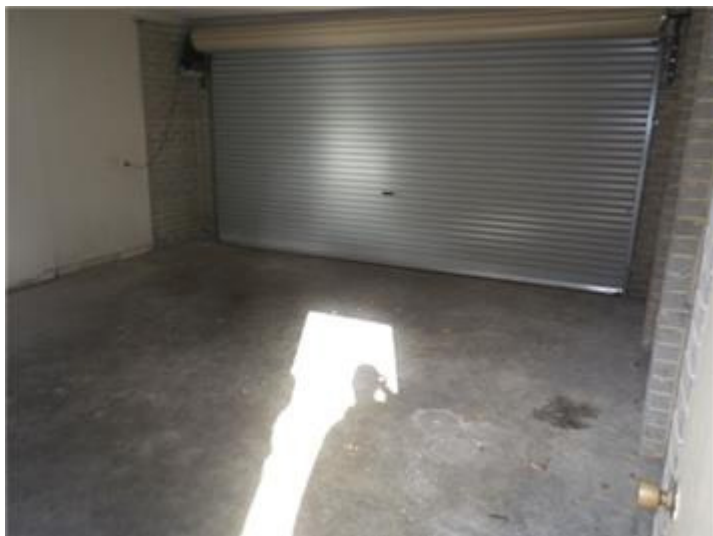
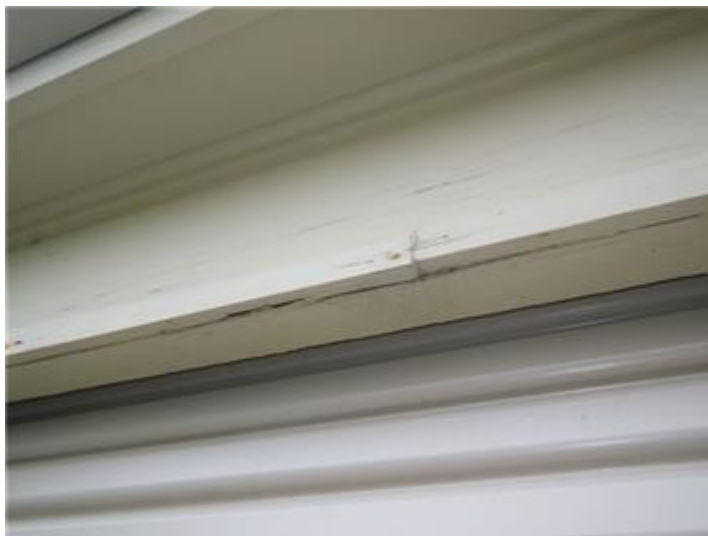
All appears to be in fair condition with some maintenance required
Rot noted to timber trim against timber beam
