*This Standard Timber Pest Detection Report (hereinafter called “the Report”) is issued subject to the Terms and Conditions of Inspection and Report set out in Clause A.1 of this document.*

Inspection Date: **11-02-2014**

NAME OF CLIENT: **Sam Sample**  
ADDRESS OF CLIENT:  
ADDRESS OF PROPERTY INSPECTED: **123 Sample Lane, Sampleton**  
DATE OF INSPECTION: **11-02-2014**  
NAME OF PRINCIPAL (where applicable):

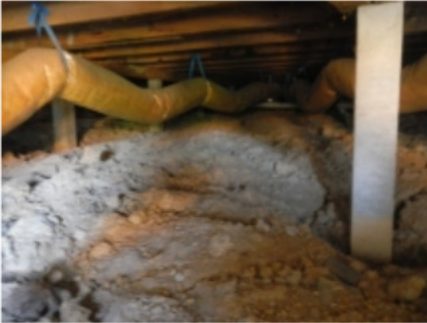
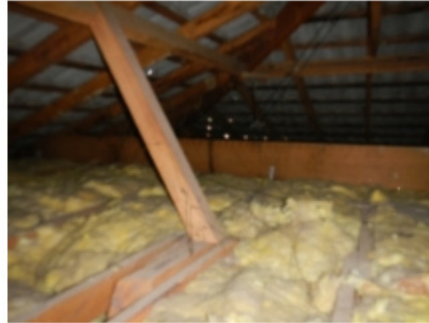
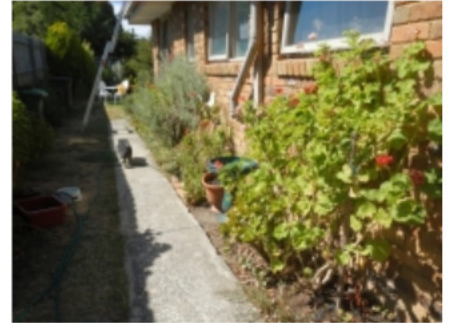
### Subfloor Space

Debris, Height restrictions, Pipe/duct work.

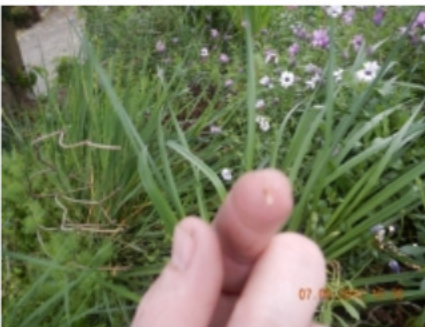
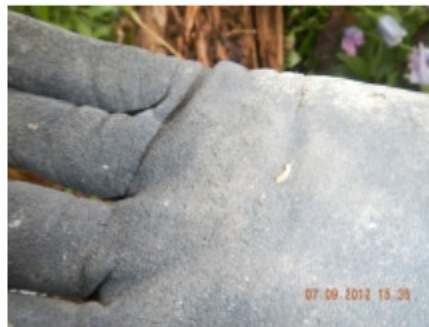
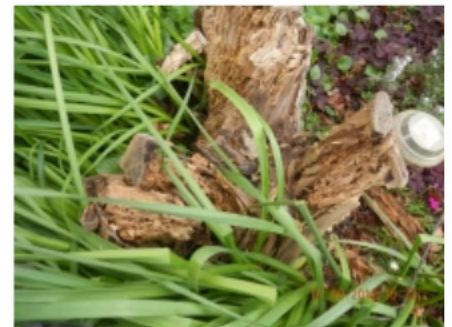
Were live termites found?

Yes

**Live termites found in tree stump:**

**Regular Inspections is recommended, Eradication and preventative as per AS 3660:**

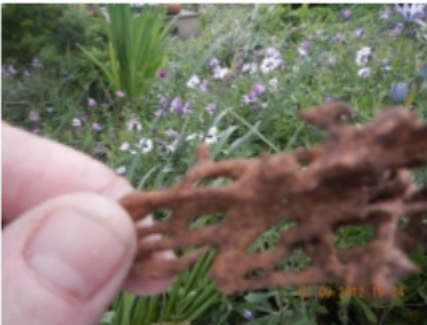
**Termite workings and/or damage was found in tree stump**

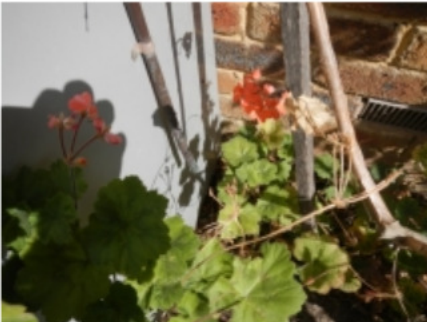
**Hot water system overflow should be drained away from house.**

**This suburb is a well known area for termite infestations to occur in homes. Whilst no activity was observed, it must be assumed that there will be active termite colonies within foraging range of the building. All care must be taken to reduce the likelihood of an infestation occurring by carrying out the recommendations within this report.**
