Melbourne Pre Purchase Property Inspections (MPPPI)

BUILDING INSPECTION REPORT

Building Type: Residential House
Description: Single Storey, 20-25 Squares of living, Garage
Estimated Age: 15-20 years old
Foundation Type: Concrete slab
Walls External: Brick veneer, Bagged and painted brickwork
Roof: Concrete roof tiles
Furniture: No
Weather Condition: Fine

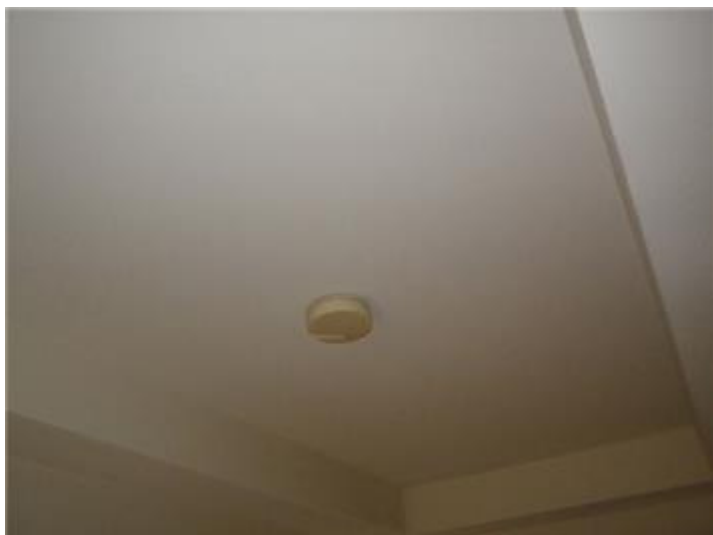
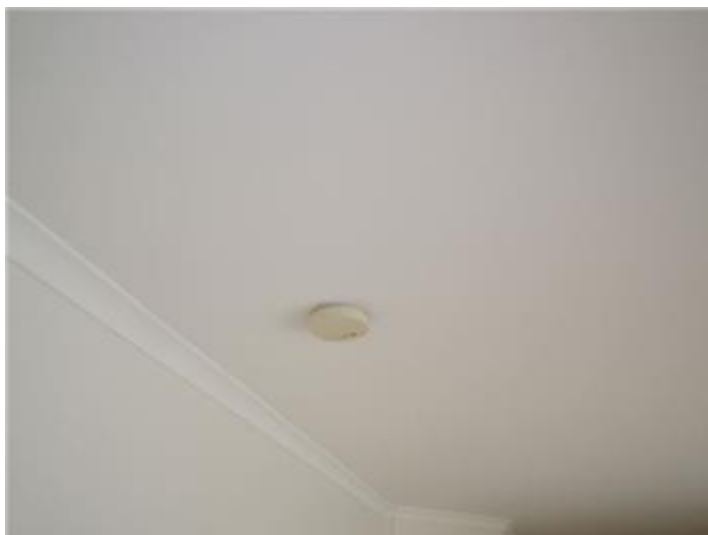
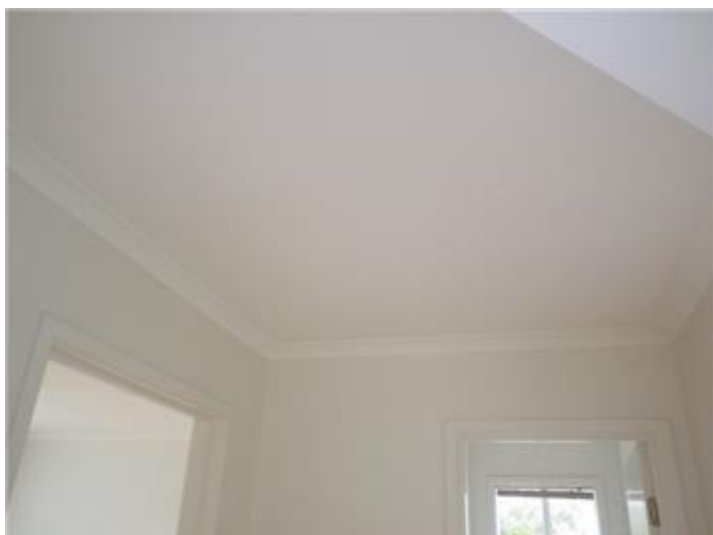
Smoke detection is fitted, however the positioning, operation or adequacy was not tested and is not commented on
No smoke detector fitted out side bedrooms 3 & 4, this is a current council requirement and should be rectified for your own safety

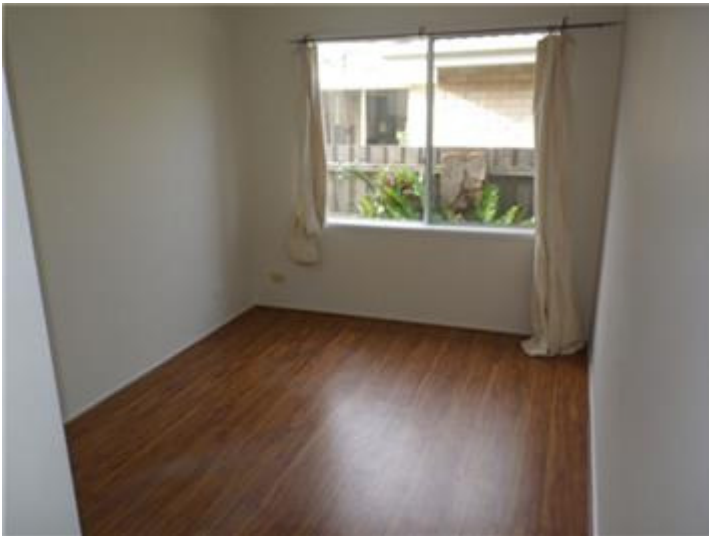
Study

Comments All appears to be in good condition with little maintenance required

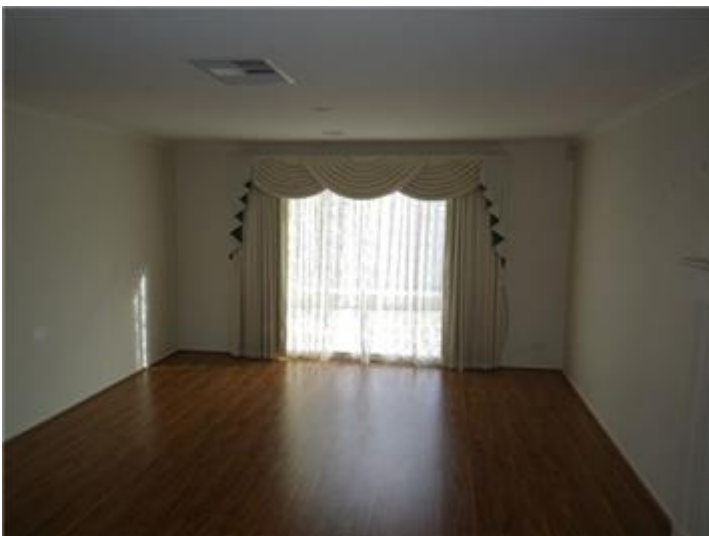
Lounge

Comments All appears to be in good condition with little maintenance required

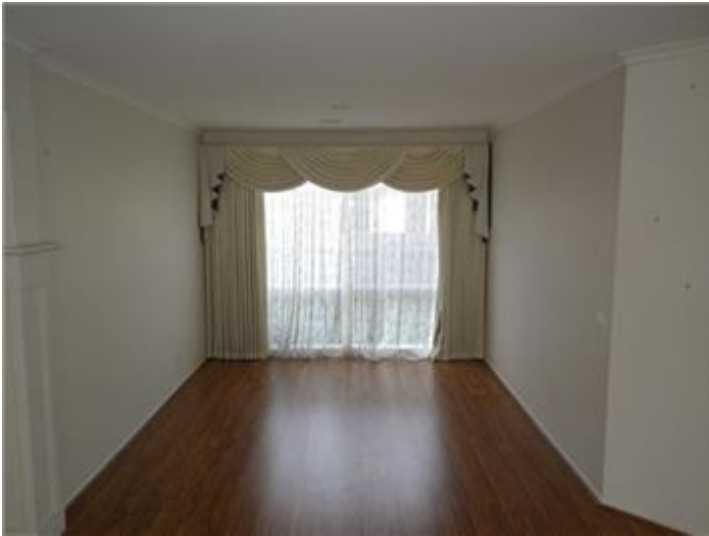
Dining

Ceilings Cornice is coming away from walls in areas and requires some refixing with cornice adhesive
Minor movement noted between plaster sheets at joint, minor repairs required and is unknown if they will return

Comments All appears to be in fair to good condition with some maintenance required

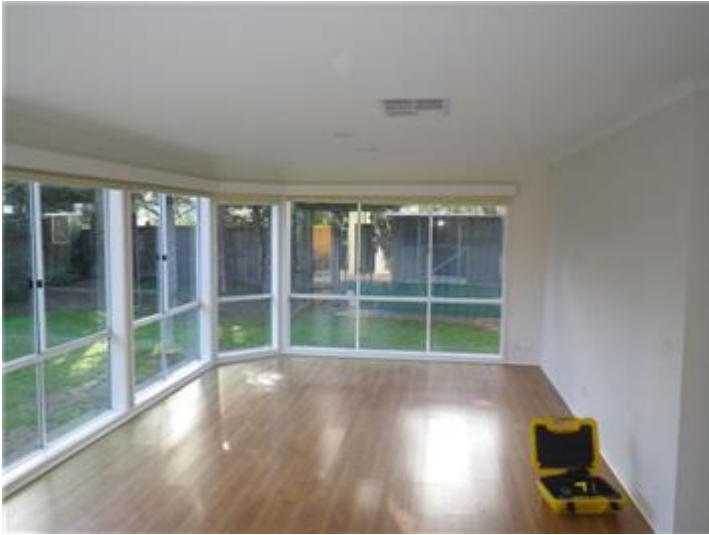
Family

Ceilings Dip noted in cornice in areas and is due to the timber roof truss flexing causing movement in plaster and should be monitored. This is common and generally around the girder trusses which take a lot more roof load than other trusses. If dipping continues then should be assessed by an engineer.

Comments All appears to be in fair to good condition with some maintenance required

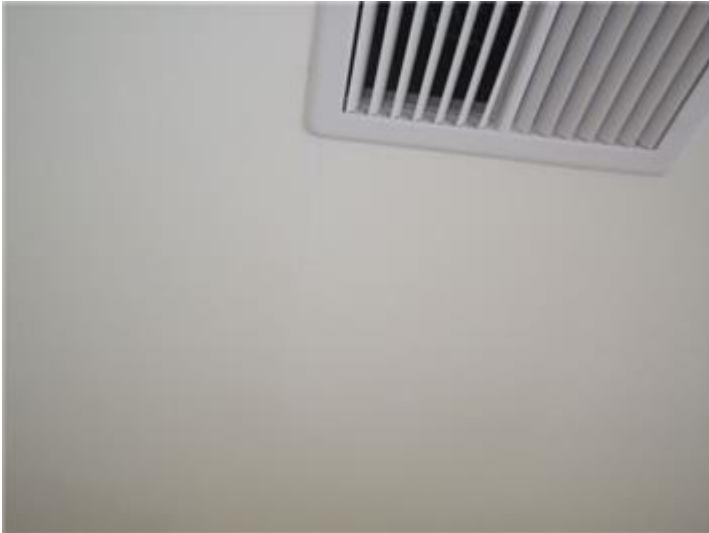
Meals

Minor movement noted between plaster sheets at join, minor repairs required and is unknown if they will return
Dip noted in cornice in areas and is due to the timber roof truss flexing causing movement in plaster and should be monitored. This is common and generally around the girder trusses which take a lot more roof load than other trusses. If dipping continues then should be assessed by an engineer.

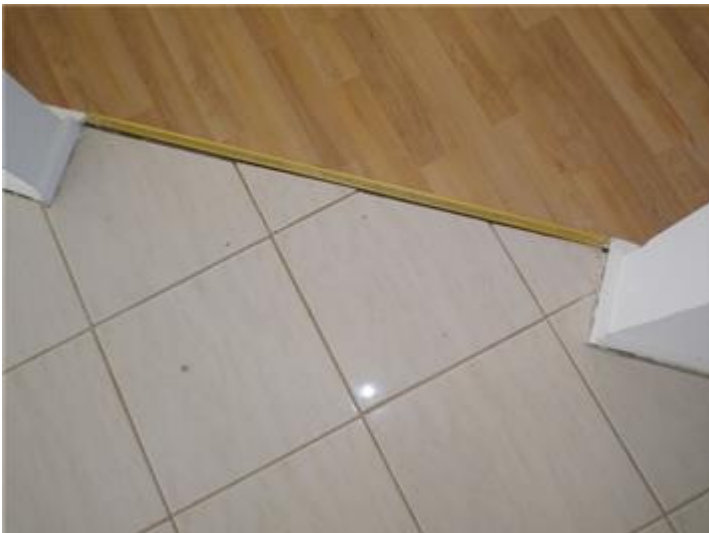
Hair line cracks noted to floor tiles in areas, could be due to movement as no expansion joints have been installed
Loose tiles noted in areas, could be due to movement or poor preparation when laid

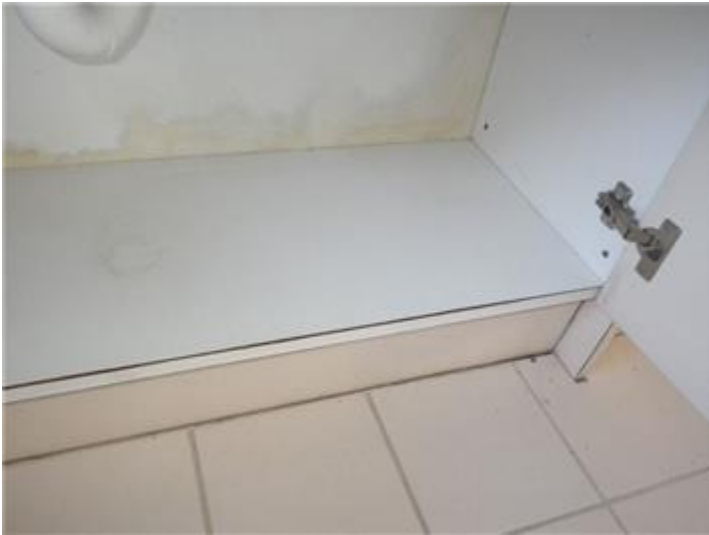
Vanity Unit

Water damage noted to base of vanity unit and requires repairs
Should be replaced

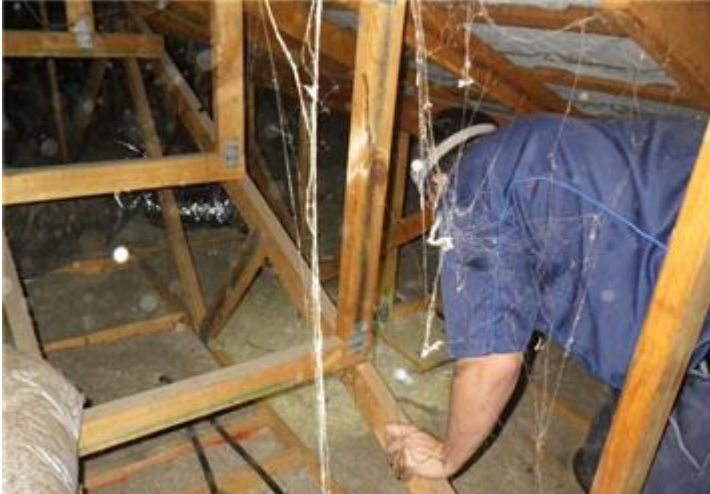
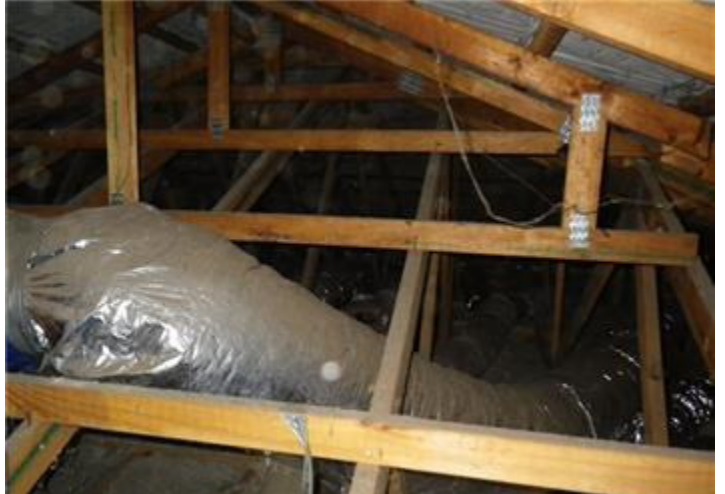
Some settlement was noted to girder trusses which have additional weight, this is to be expected to some degree and should be monitored. A timber block can be put between wall top plate and bottom cord of truss in roof space if settlement continues but should only be where webbing of truss is located and direct propping in internal walls.

Comments Ducting requires repair in areas Cost \$400

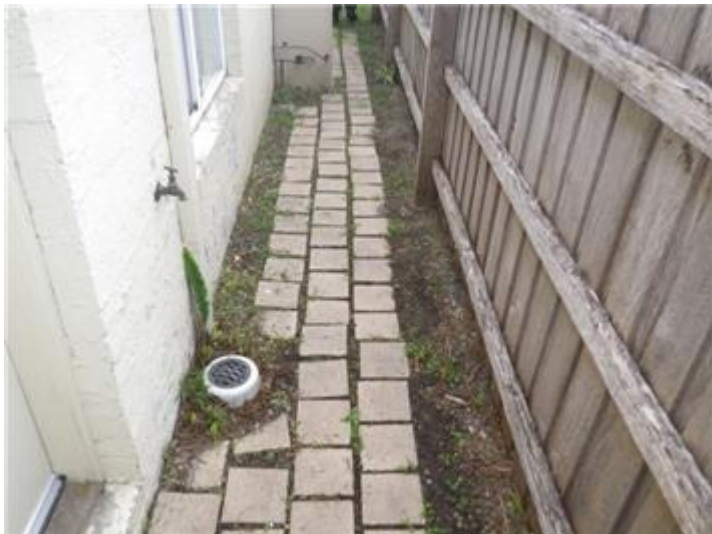
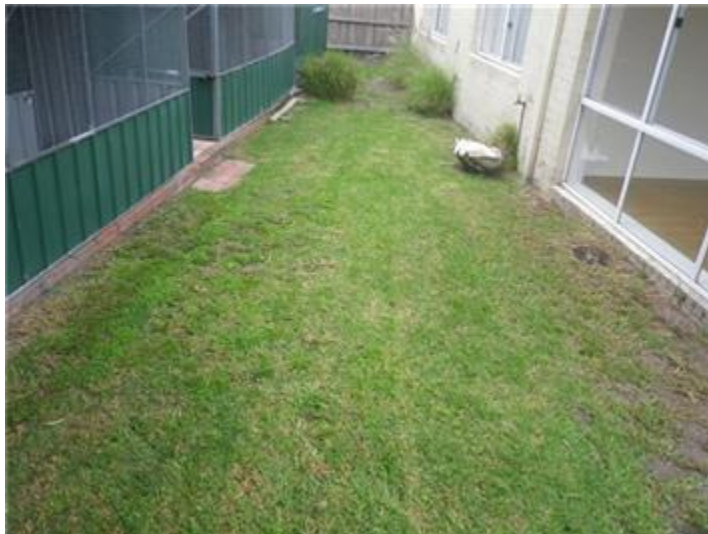
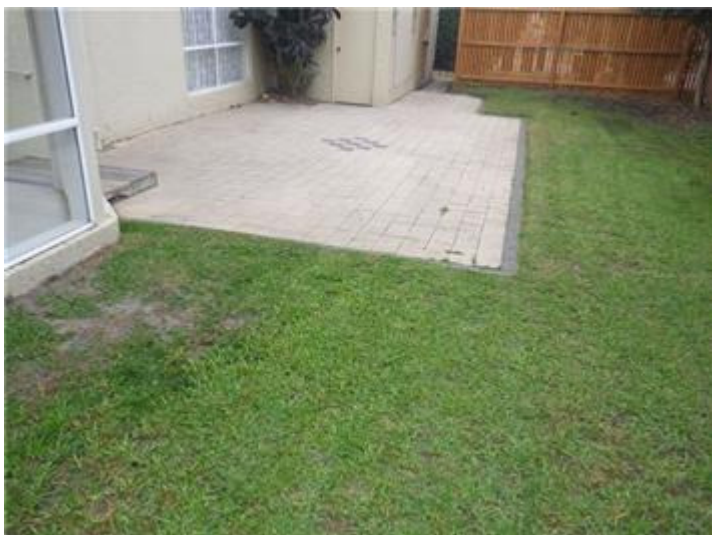
Drainage Surface water drainage may appear to be adequate but then during periods of heavy rain, may be found to be inadequate. The retention of water from surface run off could have an affect on the foundation material which in turn could affect the footings to the dwelling. Best practice is to monitor the flow of surface water and stormwater run off and have the water directed away from the dwelling or to storm water pipes by a licensed plumber/drainier. Unable to comment on storm water or sewer pipes under ground, a licensed plumber can only report on these areas.

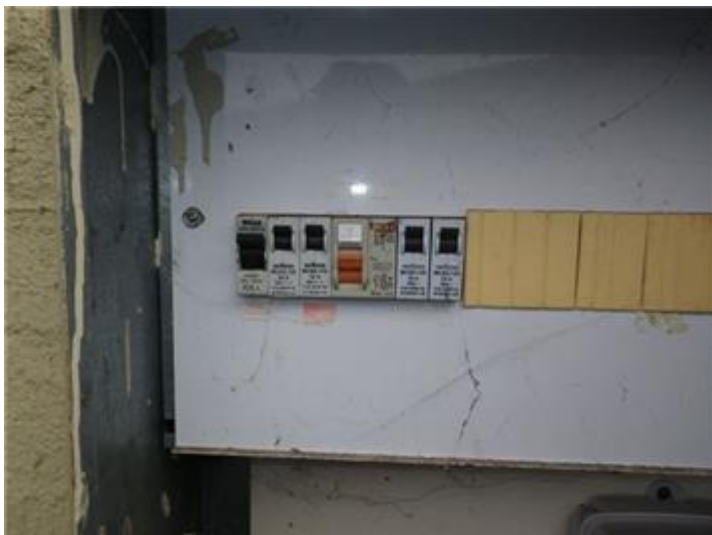
Electrical A licensed electrician can only report on all electrical services. Unknown what circuits safety switch is protecting and should be commented on by a licensed electrician. Electrician to comment on if dwelling is earthed properly.

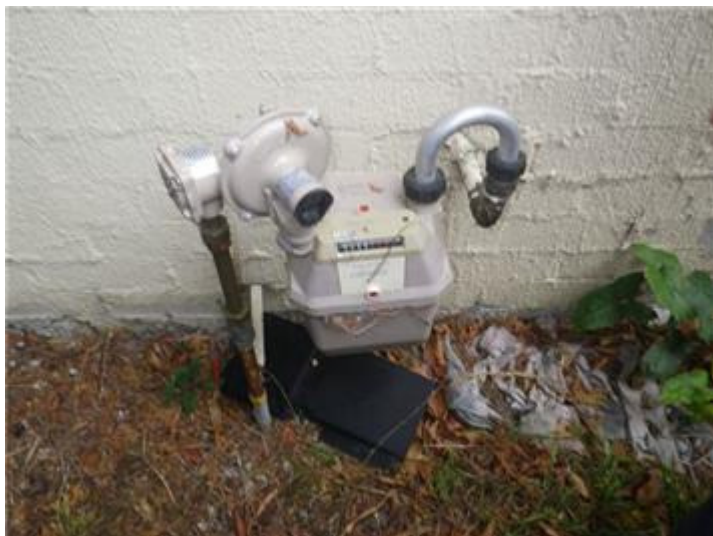
Gas service Pipes appeared serviceable and can only be reported by a licensed plumber or gas fitter. Meter at front.

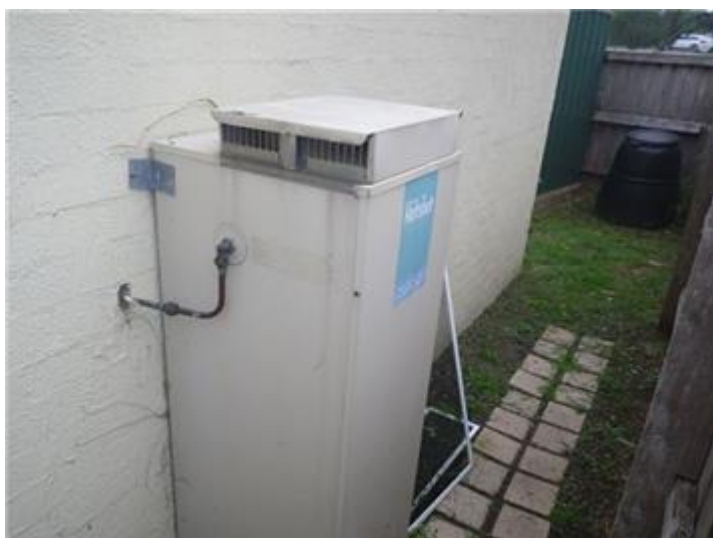
- Hot Water Service** A licensed plumber and electrician can and should only report on hot water services
Working at time of inspection but no comment is noted on operating condition
Hot water unit is near the end of its life span as it is over 10 years old, may only last another year or a possible 5 years longer

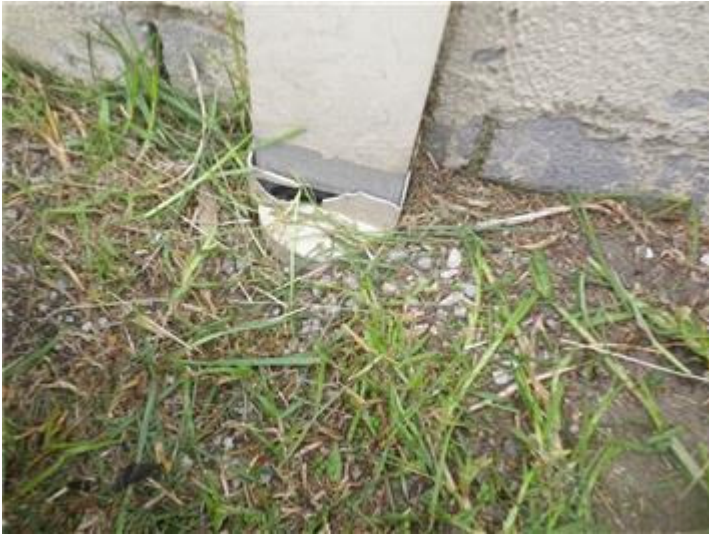
- Downpipes** Storm water connection to downpipe is broken at back of dwelling, plumber required

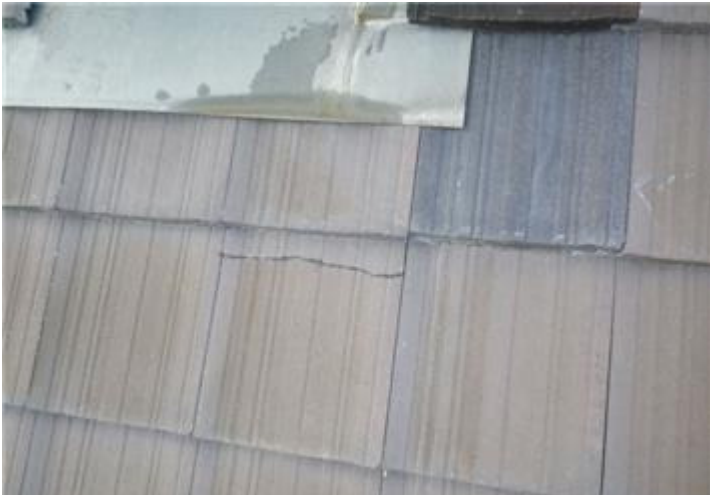
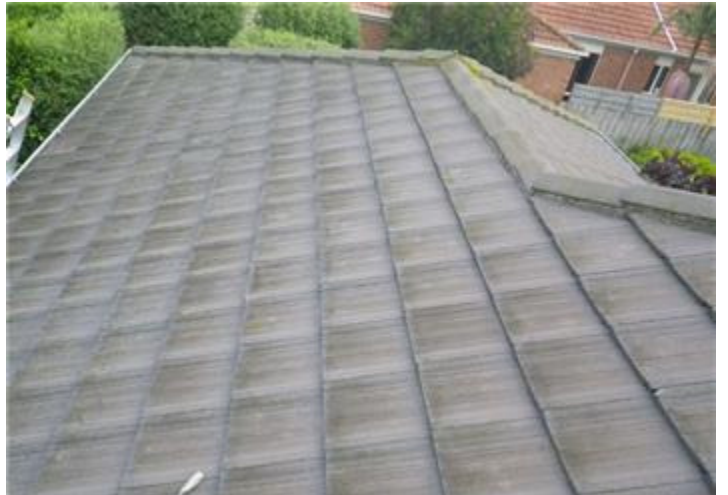
Roof Coverings

Roof tiles may require re bedded in areas and re pointed to ensure that no leaks occur, roof tiler to evaluate
Some cracked tiles noted in areas, these should be replaced as leaks are possible
The possibility of the roof leaking soon in an average rainfall is low once cracked tiles are replaced and re pointed
Roof tiler required to evaluate further

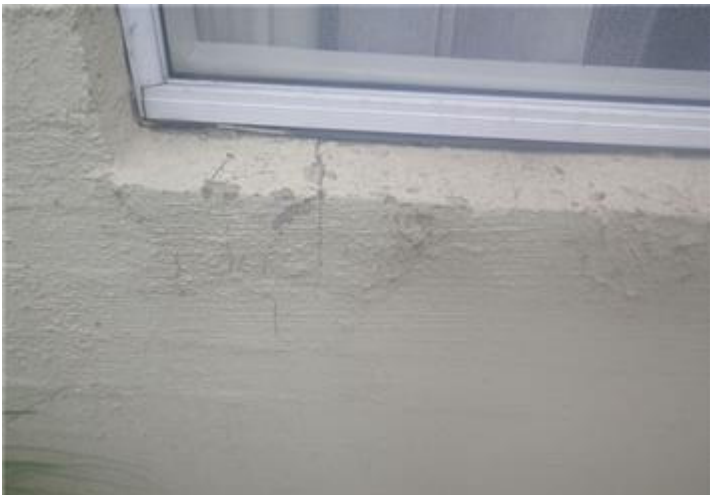
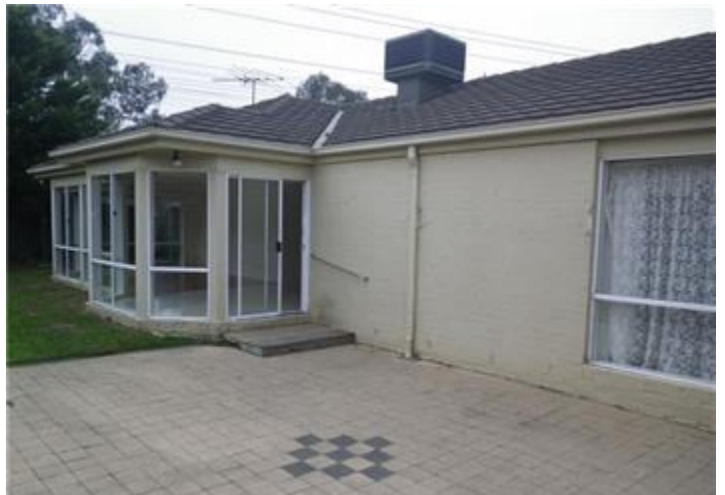
Walls

Minor movement noted in areas around dwelling and should be monitored
If you are concerned about movement increasing in size or further movement to the dwelling then a geotechnical report (soil report) will have to be commissioned. It is unrealistic for us to comment on conditions that can not be determined from a visual inspection, in other words what is happening under the dwellings foundations.
There were areas where paint was peeling off, maybe due to poor preparation
Painting required

Where drainage or gutter/downpipe problems exist around a dwelling, these can have an affect on the dwellings foundations due to changing soil conditions
Where trees are to close to the dwelling this could affect the performance of the footing as the moisture levels change in the ground. A Geotechnical Inspection can determine the foundation material and advise on the best course of action with regards to trees. large trees have been known to affect house foundations up to 1.5 times their height.

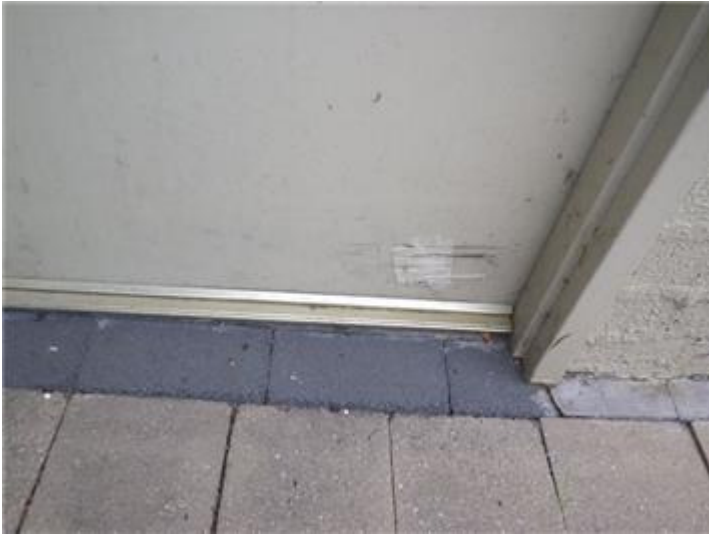
Doors Door is damaged
Surface water may run into garage
